Passenger Focus report to Cheshire
County Council on access requirements for
Chester Station

January 2007

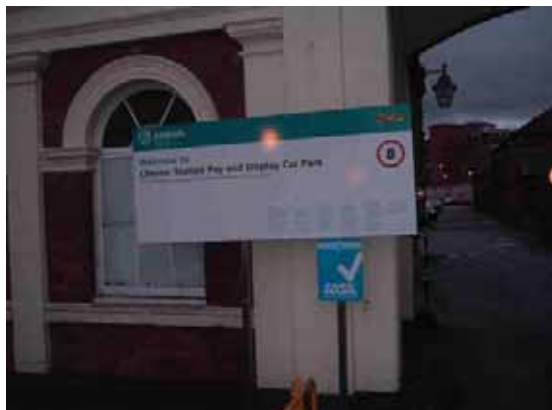
Ref	Room / Room Reference	Element	Existing Situation	Recommendations	Category	Fact Sheet Reference	Photo Ref
3	City Road / Station Road	Approach	There do not appear to be any dropping-off points for cars immediately outside the station. The area immediately in front of the station is currently reserved for a local bus service only.	Liaise with the local authority to provide a designated dropping-off point for cars outside the main entrance to the station.	D	2	
4	City Road / Station Road	Signage	There is no signage at the front of the station directing people to the two car parks.	Provide directional signage on the approach to the station in relation to the car parks.	C	23	
5	East Car Park	Signage	The signage at the entrance to this car park and the signage immediately inside the entrance incorporates good colour contrasting characteristics which is likely to make it easier to read for partially sighted people and it also employs upper and lower case text which is also likely to make it easier to read for partially sighted people and people with learning difficulties. However, the signage does not provide any information relating to accessible parking bays (i.e. whether there are any bays provided and whether parking for blue-badge holders is free).	Provide information relating to the accessible parking bays at the entrance to the car park.	C	23	1

Figure 1 – Car park signage.

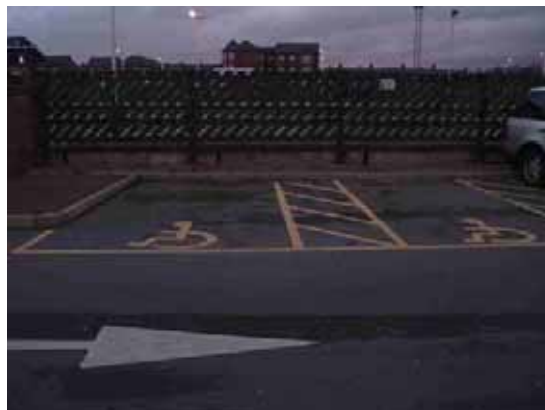
Figure 2 – Accessible parking bays.

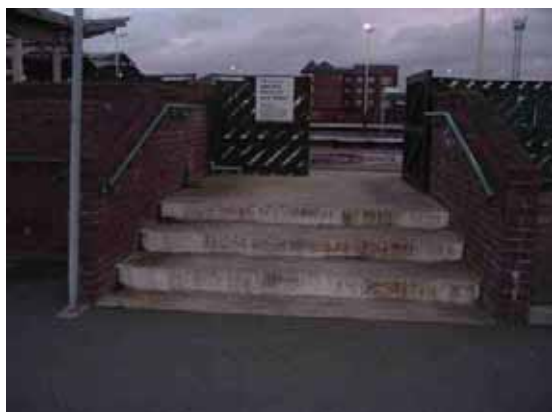
Ref	Room / Room Reference	Element	Existing Situation	Recommendations	Category	Fact Sheet Reference	Photo Ref
10	East Car Park	Signage	The signage located next to the pay and display machines confirms that blue-badge holders do have to pay to park in this area. However, this information is located on a sign over 2m high and this is likely to be more difficult to read for partially sighted people and people of shorter stature.	Provide information at a more convenient height between 1,400-1,700mm above ground level.	C	23	
11	East Car Park	Approach	The steps that lead up from this car park and onto the platform do not have colour contrasting nosings to assist partially sighted people identify individual steps.	Highlight step nosings using colour and tonal contrast.	A	11,25	3
12	East Car Park	Approach	These steps are provided with handrails on both sides which is good practice as it is likely to make the steps easier to negotiate for blind and partially sighted people and people with a reduced level of mobility. However, the handrails do not extend horizontally beyond the bottom step to provide guidance and support at this point.	Extend handrails at the bottom of this flight.	A	13	3

Figure 3 – Steps from car park.

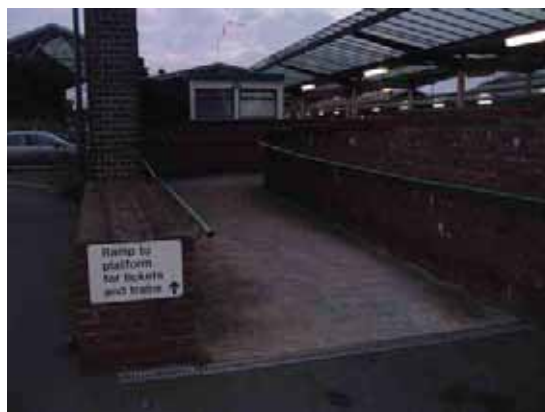
Figure 4 – Ramp from car park.

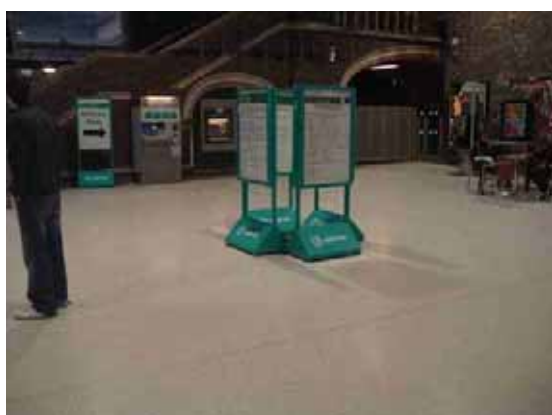
Ref	Room / Room Reference	Element	Existing Situation	Recommendations	Category	Fact Sheet Reference	Photo Ref
30	Main Entrance	Entrance	On the day of audit loose fitting mats were located immediately inside the entrance and these are likely to constitute a potential tripping hazard for blind and partially sighted people. (These mats may well be a temporary measure due to the absence of doors to keep the wet weather out).	Ensure that whilst these temporary mats are in place they do not constitute a significant tripping hazard. This could be achieved by highlighting the mats using colour and tonal contrast.	B	7,25	
31	Main Concourse	Specific Areas	Circulation space within this area is ample and there are no obvious collision or tripping hazards in the direct lines of travel. The free-standing information boards in the middle of the lobby area colour contrast strongly with the floor and can also be detected by long cane users at ground level.	N/A			5

Figure 5 – Main concourse area.

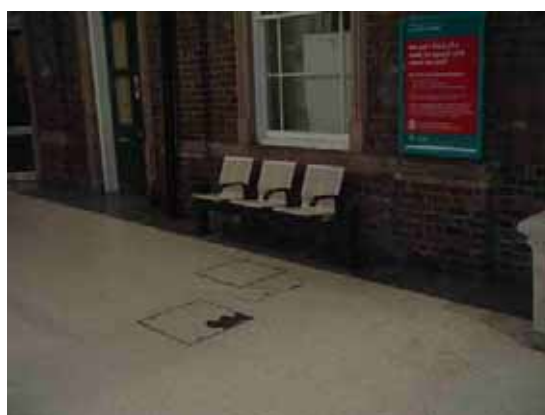
Figure 6 – Main concourse seating.

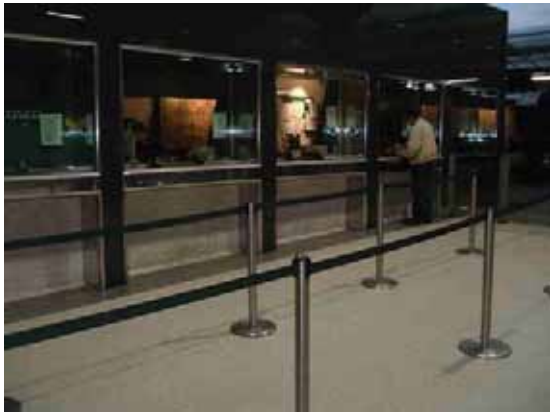
Ref	Room / Room Reference	Element	Existing Situation	Recommendations	Category	Fact Sheet Reference	Photo Ref
34	Main Concourse	Specific Areas	There are four payphones located in this area. These have coin slots located at a height of 1,400mm above floor level and keypads and handsets located at approximately 1,100mm. These features are likely to be too high for some wheelchair users and people of shorter stature.	Provide at least one telephone with controls located between 750-1,040mm above floor level.	C	9	
35	Main Concourse	Specific Areas	People queuing on the concourse to use the ticket office are controlled by tape barriers. The tape is located at a height of 900mm above floor level and there is nothing to detect at ground level for long-cane users. The uprights for this barrier are highly reflective and do not colour contrast strongly with the floor on which they are standing. These tapes and uprights constitute potential tripping hazards for blind and partially sighted people.	Replace the tape barriers with rigid colour-contrasting barriers that can be detected at floor level.	A	1	7

Figure 7 – Ticket office area.

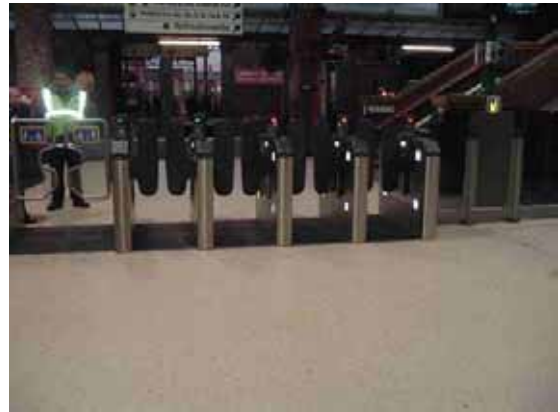
Figure 8 – Ticket barriers.

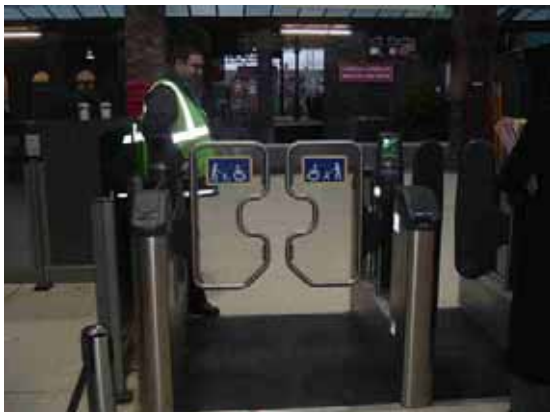
Ref	Room / Room Reference	Element	Existing Situation	Recommendations	Category	Fact Sheet Reference	Photo Ref
41	Ticket Office	Specific Areas	The sales points are fitted with glazing but there are no obstructions between the counter staff and visitors. This is a feature of good practice as it is more likely to allow people to communicate using lip reading techniques.	N/A			
42	Ticket Barriers	Horizontal Circulation	The ticket barriers do not colour contrast strongly with adjacent surfaces and are therefore likely to be more difficult to identify for partially sighted people.	Highlight ticket barriers using colour and tonal contrast.	B	25	8
43	Ticket Barriers	Horizontal Circulation	A manually operated, wider access point controlled by staff is located immediately adjacent to the standard barriers. This provides a clear opening width of 900mm and is likely to make it easier for wheelchair users, people using mobility aids and people with assistance dogs to negotiate the barriers.	N/A			9

Figure 9 – Accessible barrier.

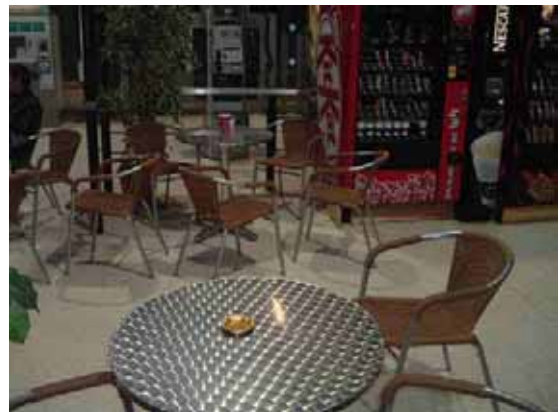
Figure 10 – Café table.

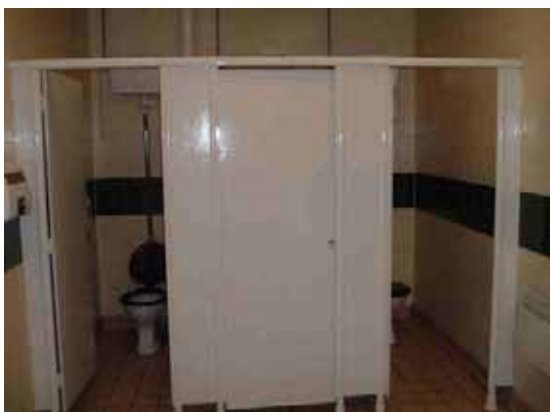
Ref	Room / Room Reference	Element	Existing Situation	Recommendations	Category	Fact Sheet Reference	Photo Ref
58	Trekkers Express Café	Specific Areas	The real-time information screen located inside this café is located at a height of approximately 2m above floor level. The screen employs upper and lowercase text and good colour contrast exists between the text and the background. The information is refreshed and not scrolled. These are features of good practice that are likely to make the information easier to read for partially sighted people and people with learning difficulties.	N/A			
59	Male Toilet Facility (adjacent concourse area)	Toilets	The entrance to this facility provides just over 700mm clear opening width. This is unlikely to be sufficient for people using mobility aids or people with assistance dogs.	Widen door to provide at least 750mm clear opening width.	C	5	
60	Male Toilet Facility (adjacent concourse area)	Toilets	There is a lack of strong colour contrast in this facility between items such as the wash basins and the walls on which they are mounted, and the cubicle doors and adjacent pilasters. There is also a lack of contrast between the hand-drying machines and the walls on which they are mounted. The floor and the walls also do not colour contrast strongly. This lack of colour contrast is likely to make the facility more difficult to use for partially sighted people.	Highlight critical surfaces and fixtures and fittings using colour and tonal contrast.	B	25	11

Figure 11 – Toilet cubicle.

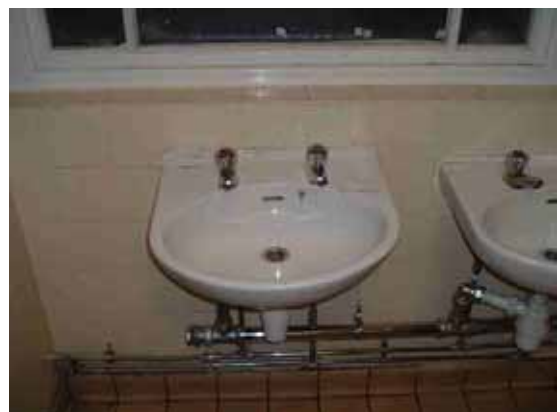
61	Male Toilet Facility (adjacent concourse area)	Toilets	The wash basins in this facility are fitted with twist-action taps which are likely to be more difficult to use for people with a reduced level of manual dexterity.	Replace existing taps with single lever-action mixer taps.	C	20	12

Figure 12 – Wash basin.

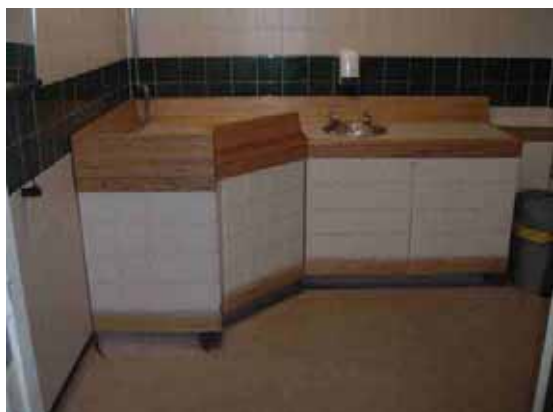
Ref	Room / Room Reference	Element	Existing Situation	Recommendations	Category	Fact Sheet Reference	Photo Ref
69	Accessible Toilet Facility and Baby-Change Facility	Toilets	The location of these two facilities in one room does not meet best practice guidelines and is likely to compromise the effectiveness of both functions. The space within this facility has an irregular, tapering shape and measures 1,300mm deep at the narrowest point to 2m depth at the widest point. The width of the facility is 2,700mm. This does not meet the configuration or dimensions recommended in best practice guidelines and is likely to be more difficult to use for wheelchair users.	Relocate the baby change facilities. Consideration should be given to incorporating baby-change facilities in a separate facility. Redevelop this facility to meet best practice guidelines. (The relocation of the baby-change facilities will accommodate the redevelopment of this area).	D	19,20	13

Figure 13 – Accessible toilet and baby change facility.

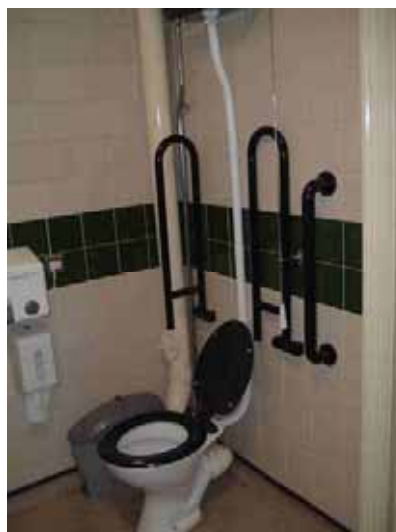
Figure 14 – Accessible toilet.

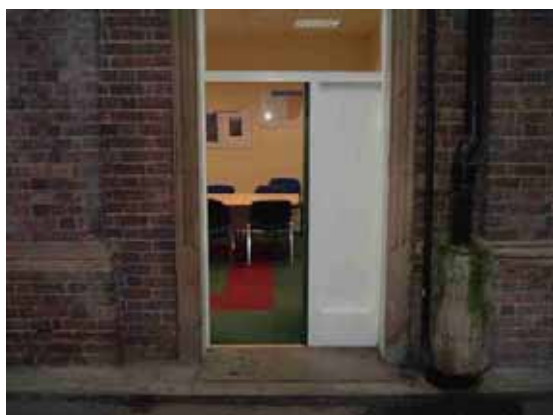
Figure 15 – Meeting room door.

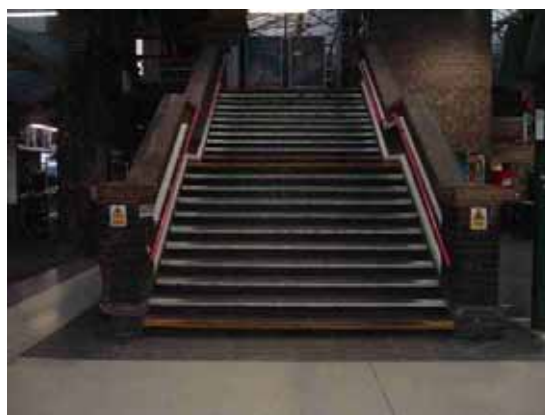
The step nosings on the main flight of steps inside the station have been highlighted but the paint has become worn away in many places and this is likely to make it more difficult for partially sighted people to negotiate the steps. The steps between the east car park and the disused platform do not have highlighted nosings at all. It is recommended that the step nosings on all steps should be highlighted using colour and tonal contrast.

The handrails on these steps do not meet best practice guidelines and this is likely to make it more difficult for blind and partially sighted people and people with a reduced level of mobility to negotiate the steps. It is recommended that the handrails are upgraded to meet best practice guidelines.

Ref	Room / Room Reference	Element	Existing Situation	Recommendations	Category	Fact Sheet Reference	Photo Ref
86	Stairs	Vertical Circulation	The steps that provide access to platforms 4 to 7 from the main concourse area do have highlighted nosings which is a feature of good practice. However, the highlighting is extremely worn in places and this is likely to make the steps more difficult to use for partially sighted people.	Refresh the step nosings in order that a strong contrast is provided between the steps and the step nosings.	A	11,25	16
87	Stairs	Vertical Circulation	The steps are provided with handrails but the handrails do not extend horizontally at the bottom of the flight to provide support for people with a reduced level of mobility or guidance for blind and partially sighted people.	Extend the handrails at the bottom of this flight in accordance with best practice guidelines.	A	13	16

Figure 16 – Main stairs.

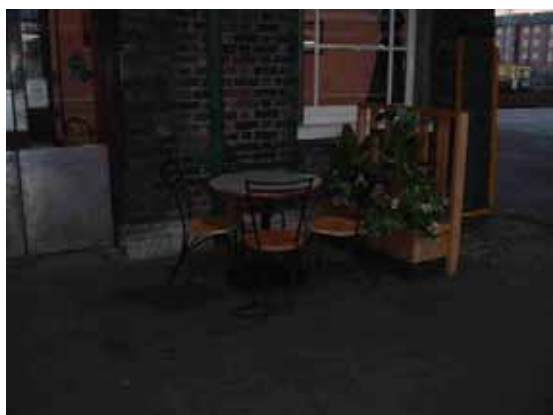
103	Trekkers Express Café (Between Platforms 4 and 7)	Specific Areas	These entrance doors are fitted with kick-plates which is a feature of good practice as they protect the doors from the foot-plates of wheelchairs. However the kick-plate on the outside of the door on platform 7 was missing on the day of audit.	Replace missing kick-plate.	B	5	
104	Trekkers Express Café (Between Platforms 4 and 7)	Specific Areas	None of the seating provided inside and outside this café has armrests and this is likely to make the seats more difficult to use for people with a reduced level of mobility and blind and partially sighted people who require armrests for support and guidance when sitting down or rising from a seated position.	Provide a range of seating some with armrests and some without armrests.	C	15	17

Figure 17 – Café seats.

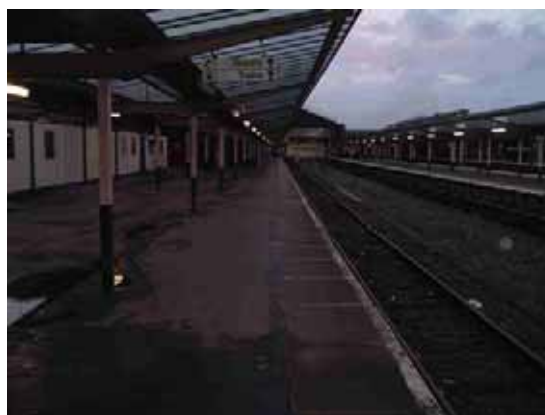
Figure 18 – Disused platform.
