Riders, Walkers, Wheelers Strategic Road Network Research South West Region: A38 Liskeard

March 2024

This report provides findings for the following location: **A38 Liskeard (Old Road Junction – Lantoom Quarry)**. The report is structured as follows:

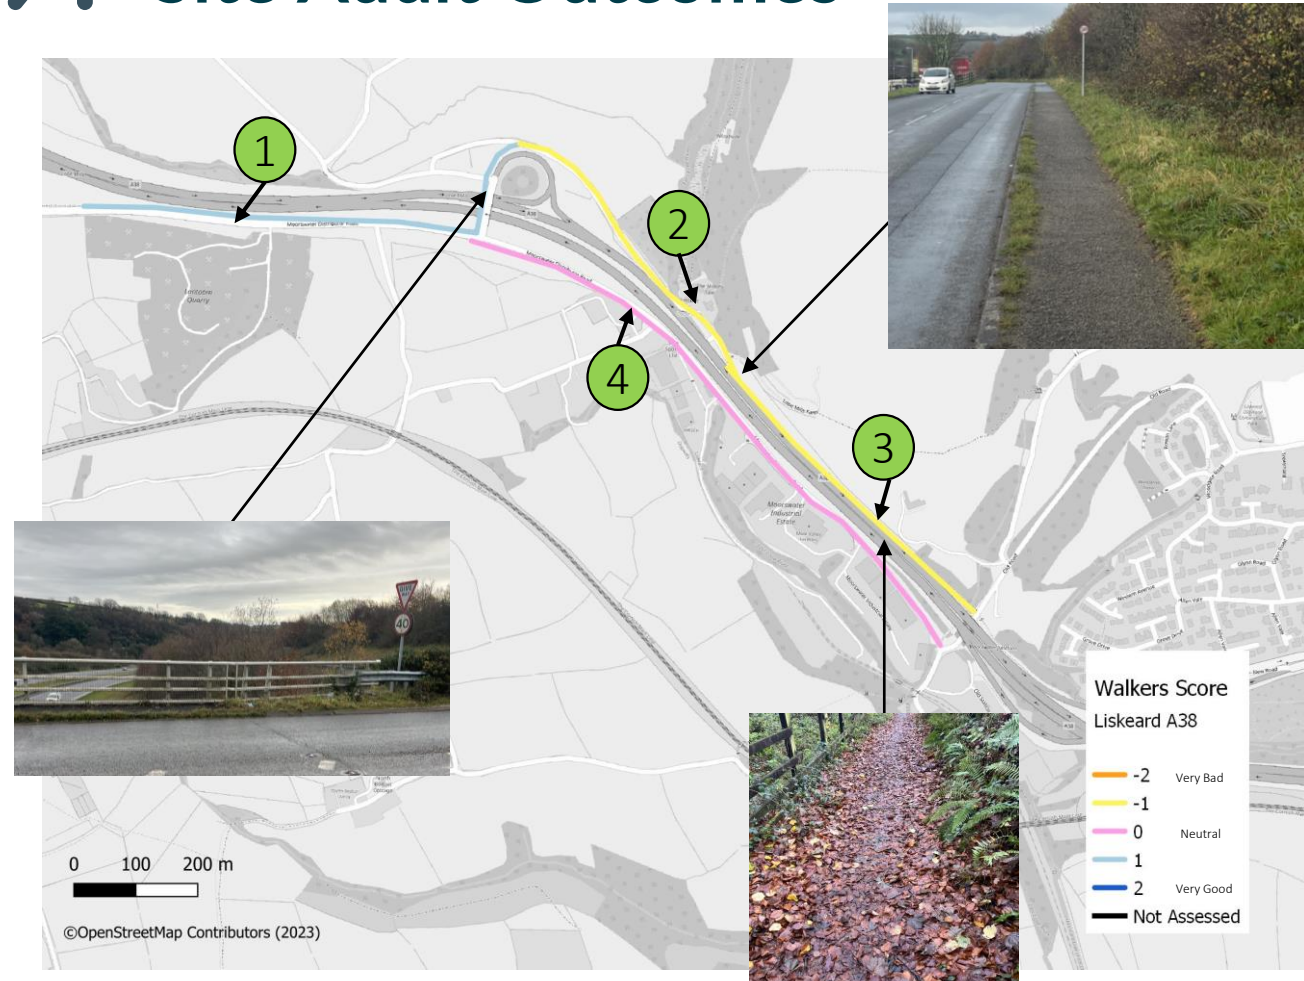
Link	Parameter	Provisions for walkers
1	Footway Location	Shared footway and cycleway adjacent to A38 on one side of the road (segregated)
	Footway Width	Bridge footway is 3m wide, however other areas have a minimum 1.5m width
	Segregation	Grass verge present
	Surface	Generally smooth/flat surface
	Bridges	Bridge parapets only 1m – needs to be 1.5m
	Lighting	Lack of lighting
	Wayfinding	Clear signage present
2	Footway Location	Half of link has shared path/ other half has no infrastructure for walkers
	Footway Width	Less than 3m wide path
	Surface	Uneven surface
	Lighting	Lack of lighting
3	Maintenance	Overgrown greenery
	Wayfinding	Signage at start and end of link showing link is shared
	Footway Location	Segregated shared path adjacent to A38
4	Footway Width	Lack of consistency in width
	Lighting	Lack of lighting
	Maintenance	Overgrown greenery, muddy, some littering
	Gradient	Steep sections
5	Footway Location	Segregated shared path adjacent to A38

Key outcomes can be found in the table shown here. In summary, segregated shared foot and cycleways are available at different sections across the site, however there is a lack of consistency in width, surface, gradient and maintenance of these. Lighting is also lacking across the site.

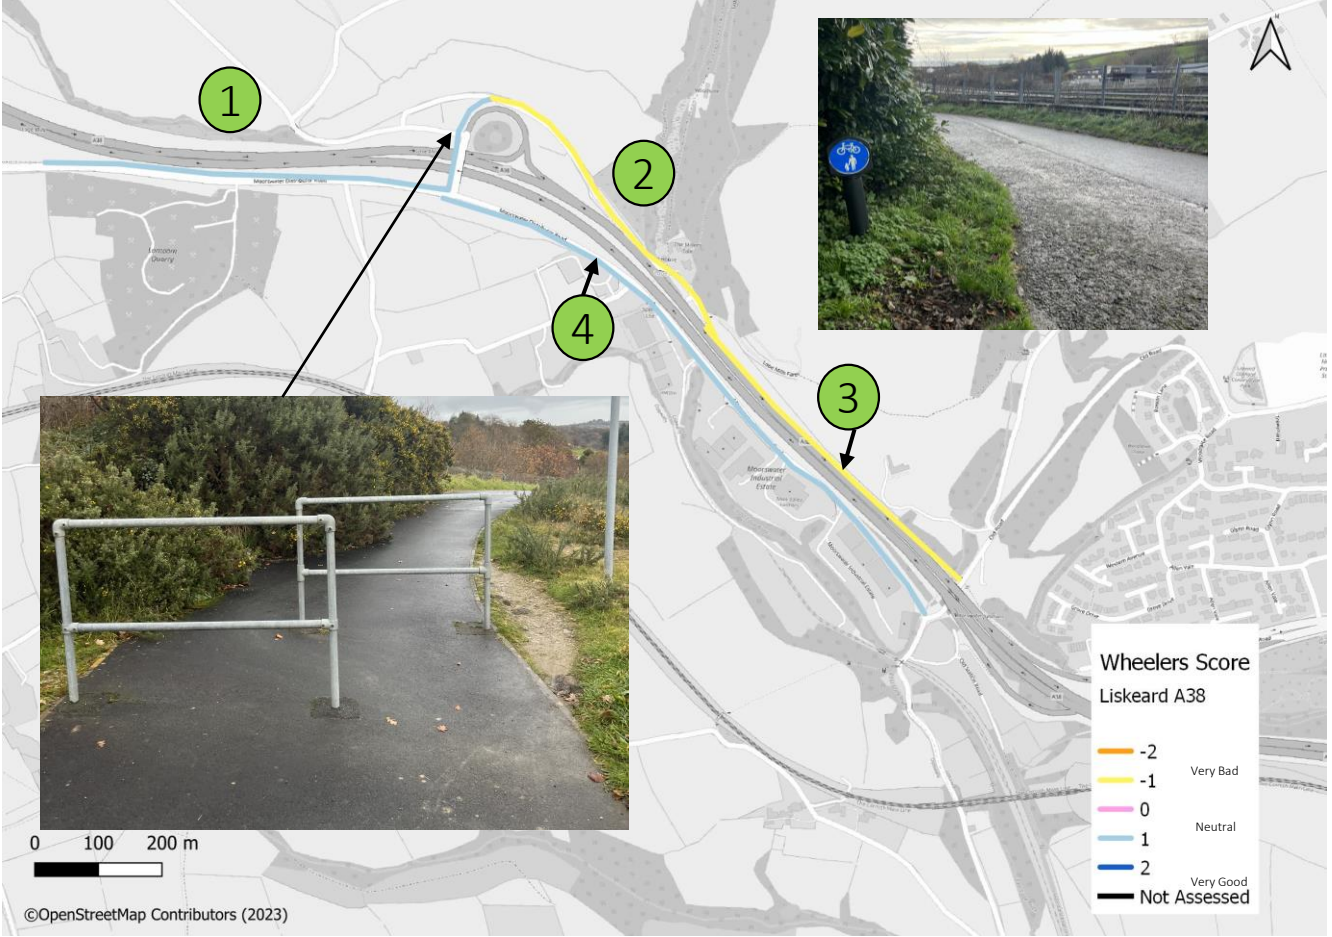
Link	Parameter	Provisions for wheelers
1	Cycleway Location	Shared footway and cycleway adjacent to A38 on one side of the road (segregated), gate near bridge which may not be wide enough for adapted cycles
	Cycleway Width	Bridge footway is 3m wide, however other areas have a minimum 1.5m width
	Segregation	Grass verge /kerbs present
	Surface	Generally smooth/flat surface
	Bridges	Bridge parapets only 1m – needs to be 1.5m
	Lighting	Lack of lighting
	Wayfinding	Clear signage present
2	Cycleway Location	Half of link has shared path/ other half wheelers share road with vehicles
	Cycleway Width	Less than 3m wide path – conflict with walkers and traffic
	Surface	Uneven surface- could resurface path
	Lighting	Lack of lighting
	Maintenance	Overgrown greenery
3	Cycleway Location	Segregated shared path adjacent to A38
	Cycleway Width	Lack of consistency in width with narrow areas- conflict with walkers.
	Lighting	Lack of lighting

Key outcomes can be found in the table shown here. In summary, segregated shared foot and cycleways are available at different sections across the site, however there is a lack of consistency in width and maintenance. Lighting is also lacking across the site. Wheelers have to mount off bikes to use unsignalised crossings in Link 4.

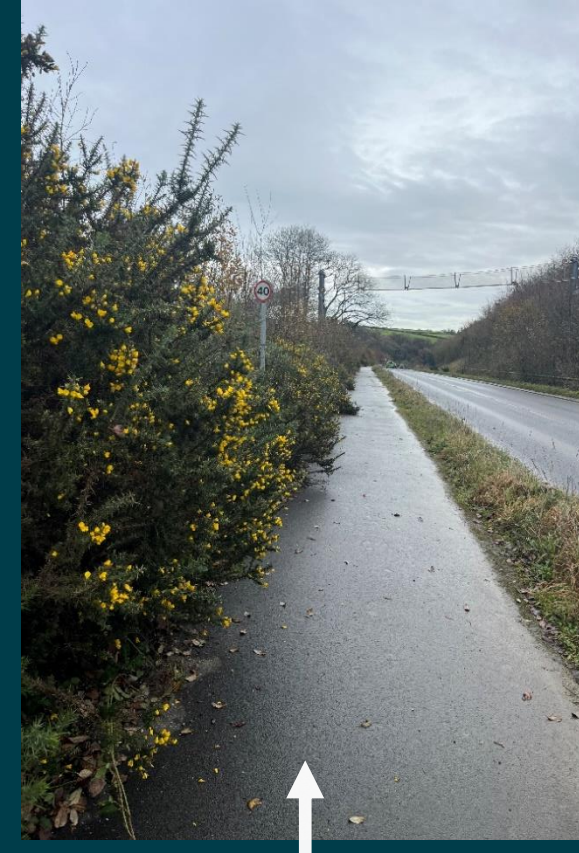
- Overgrown greenery along the path cause punctures (see picture).

“This part has a lot of gorse and brambles which protrude and cause punctures.” (Walker and Wheeler, Interactive Map)

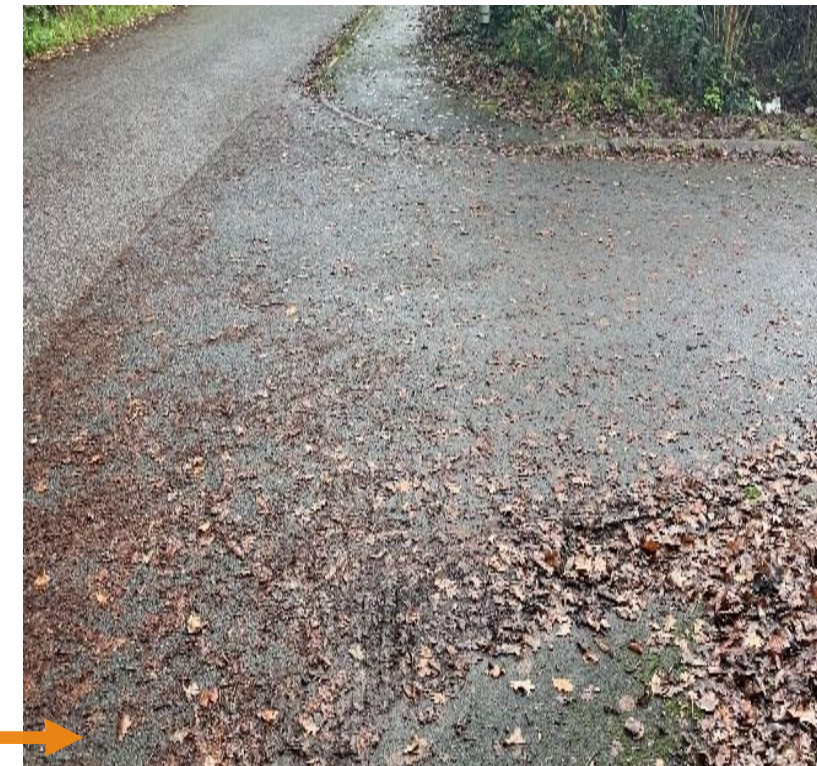
“It’s alright for myself [referring to the road surface along the link], but if you’re pushing a pram or something, it’s not any good [...] we often get people pushing their pushchairs down here.” (Walker and Wheeler, Accompanied Journey)

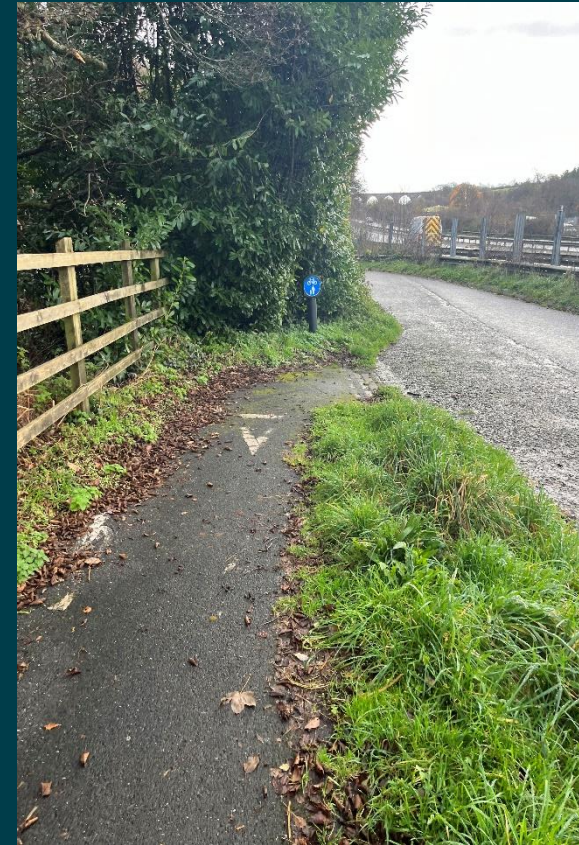
- Poor wheelchair access at the Dobwalls Bypass where Link 2 meets Link 3, due to the lack of dropped kerbs.
- Narrow paths to access the woodlands create conflict between walker and wheelers.
- Lack of lighting, though there was acknowledgement of the proximity to the traffic on the A38 and the danger that adding lights may pose to motorists.
- Lack of waste bins may be challenging for dog walkers.
- Surface quality may be fine for walkers, but challenging for walkers with prams.
- Lack of a shorter, more direct alternative route to reach the woodlands north of the Dobwalls Bypass from Liskeard town, due to landowners blocking access to bridleways and footpaths.

“When you get to the top, at the other end [referring to where Link 3 joins Link 2], the kerb isn’t down anywhere, so you have to jump your bike off the kerb.” (Walker and Wheeler, Accompanied Journey)

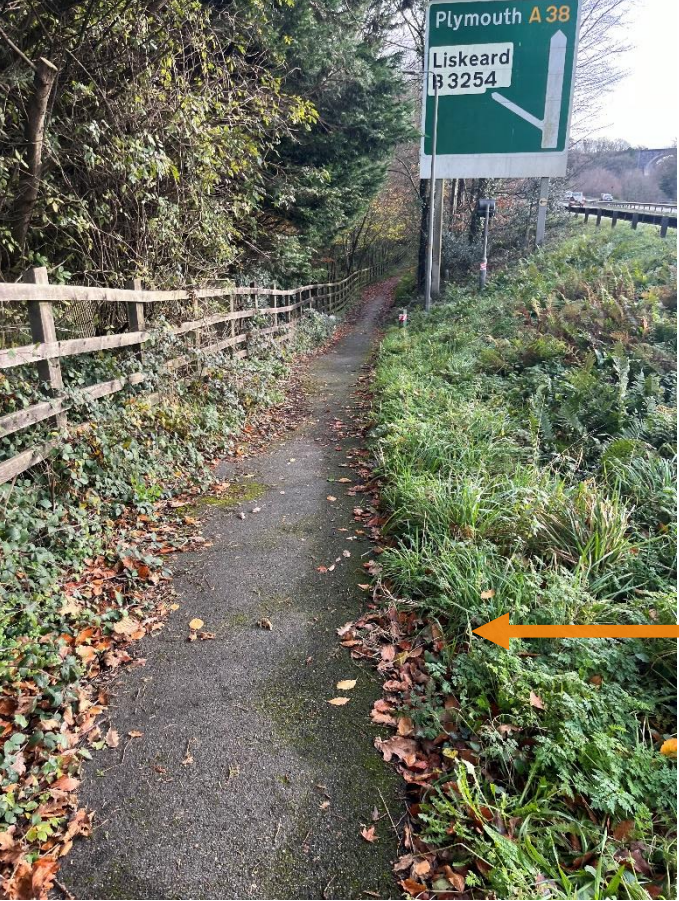
“It’s a bit slippery [...], they do that [referring to maintaining part of the path that comes onto A38], but they don’t bother coming down here [referring to the part of the path by Old Road].” (Walker and Wheeler, Accompanied Journey)

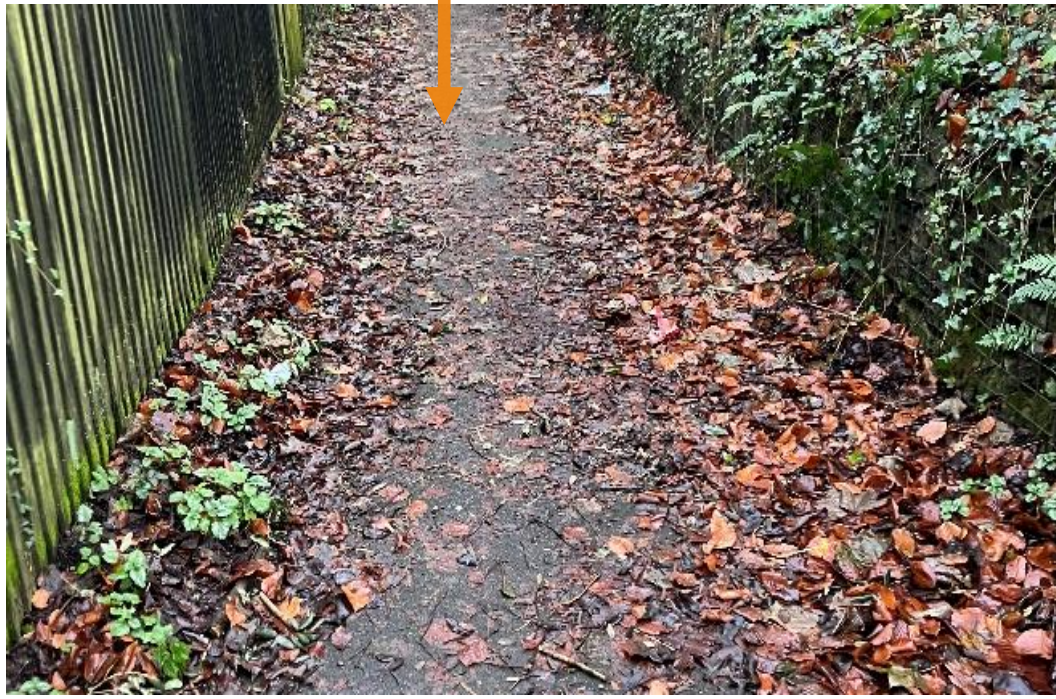
“Where they don’t maintain the left-hand side coming down, it gets narrower, so it gets very tight for people to pass.” (Walker and Wheeler, Accompanied Journey)

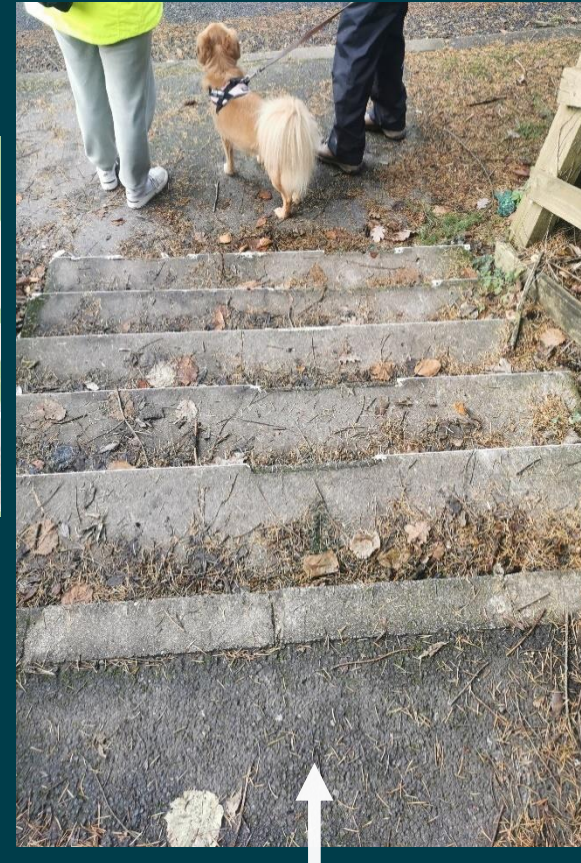
- Slippery surface and visible cracks and dips on the steps at the end of the link that accesses Old Road (see picture of steps on the right).
- Narrow shared use path at the end of the link that accesses Old Road creates conflict with wheelers, with walkers having to move out the way of wheelers.

“It’s [referring to cycling on the site] alright, it’s just steep coming back and of course you have to get off your bike and come up [...], you have to carry it up the steps.” (Walker and Wheeler, Accompanied Journey)

- Improve access to the link for wheelchair users and walkers with prams, by adding a ramp to replace the steps at Old Road.
- Improve lighting provision along the link, though some acknowledge this may be dangerous due to proximity to the A38, and may not be a priority due to the low activity along the link.

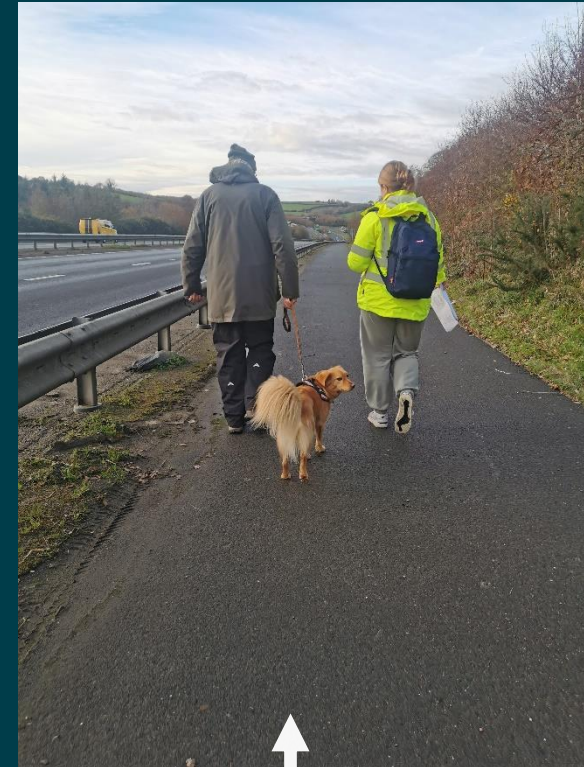
"I mean, there needs to be a slight ramp [referring to steps at Old Road]." (Walker and Wheeler, Accompanied Journey)

- Improve access for wheelers to the link by adding a ramp to replace the steps at Old Road.
- Improve lighting provision along the link though some acknowledge this may be dangerous due to proximity to the A38, and may not be a priority due to the low activity along the link.

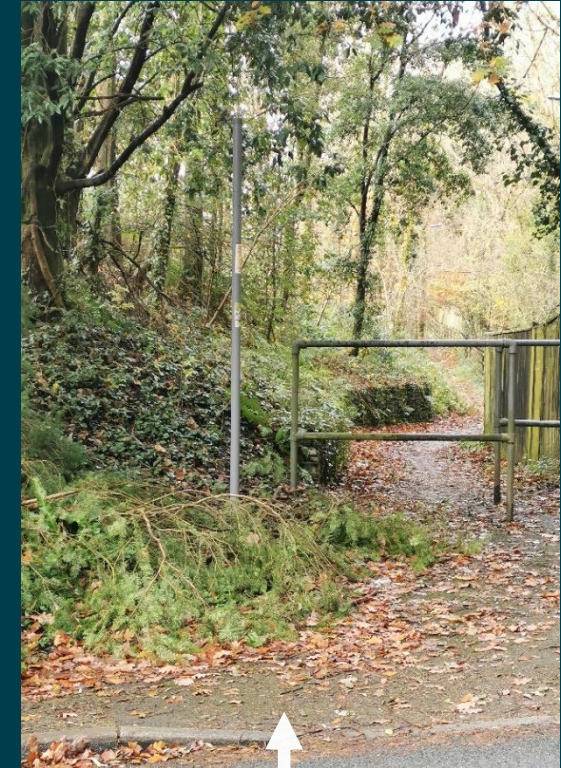
“This [referring to the path at Old Road] is part of a key route into town and replacing the stairs with a ramp should be a priority.” (Walker, Interactive Map)

- Replace cycle gates at the Old Road end of the link with priority cycle crossing infrastructure (see picture).
- While not directly related to the link, the following improvements were suggested for the footpath adjacent to the A38 eastbound slip road onto New Road, which is a continuation of Link 3 past Old Road, and thus could improve access to and from the link:

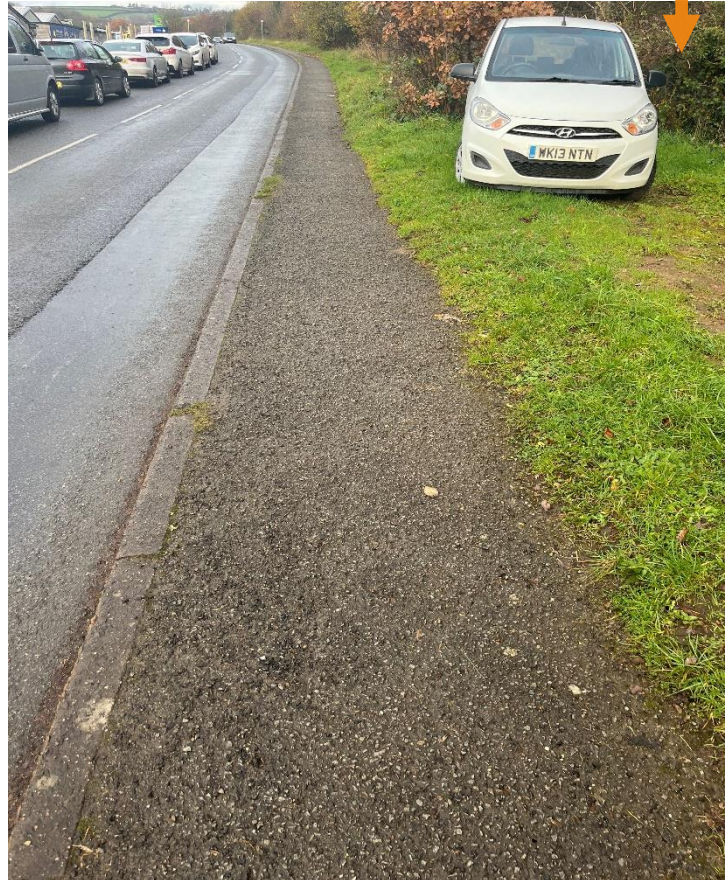
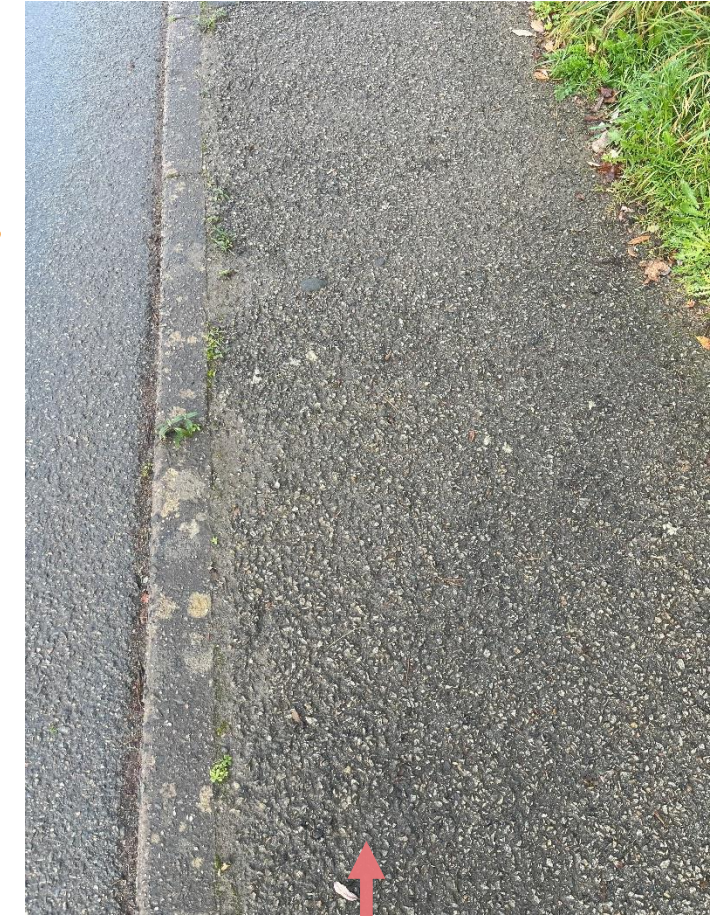
“Look how bad this is, there’s always cars parked on there [referring to pavement along Moorswater Industrial Estate], so you always have to stop here and let people past.” (Walker, Accompanied Journey)

“It would be great if it was smoother and wider [referring to part of the path along Moorswater Industrial Estate].” (Walker, Business)

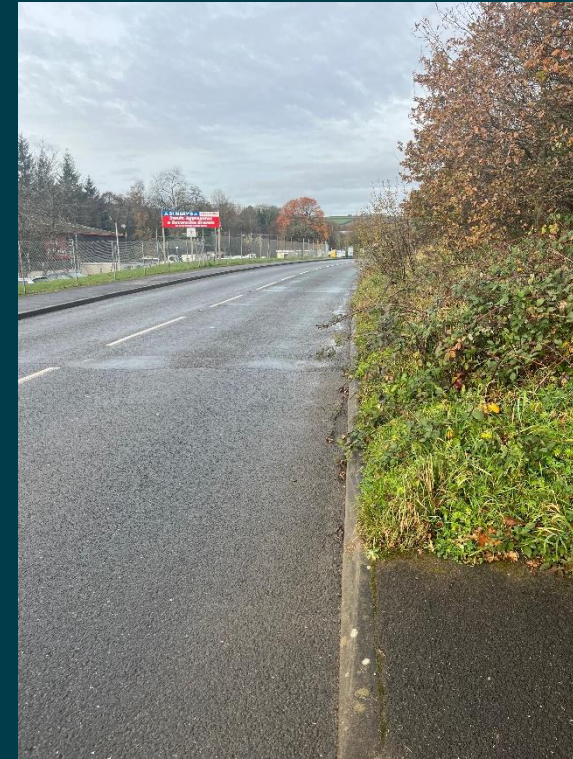
- Unsafe crossing point at Moorswater Industrial Estate where the path on one side of the road ends abruptly. There is limited visibility of oncoming vehicles, causing safety concerns for wheelers trying to cross the road to re-join the shared use path.

“The only place you have to cross here is where this path ends and that path finishes [...]. If the cars coming down this way, fast, and you’re crossing from here to there, you’re gonna see it at the last minute [...] if someone’s on a walking stick or... they aren’t gonna be getting out the way fast enough.” (Walker and Wheeler, Accompanied Journey)

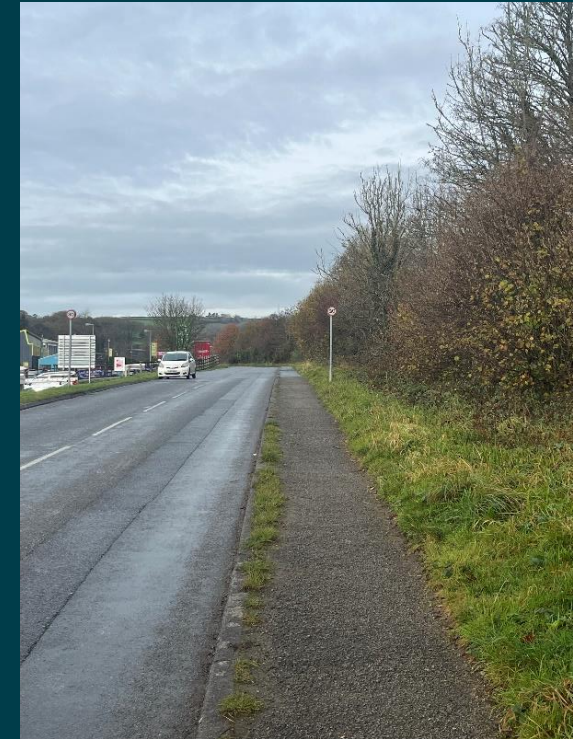
“Unnecessary second lane [referring to westbound A38 passing under the bridge] could be converted to a good safe footway connecting to footpath by Old Railway Cottage to Old Station Road.” (Interactive Map)

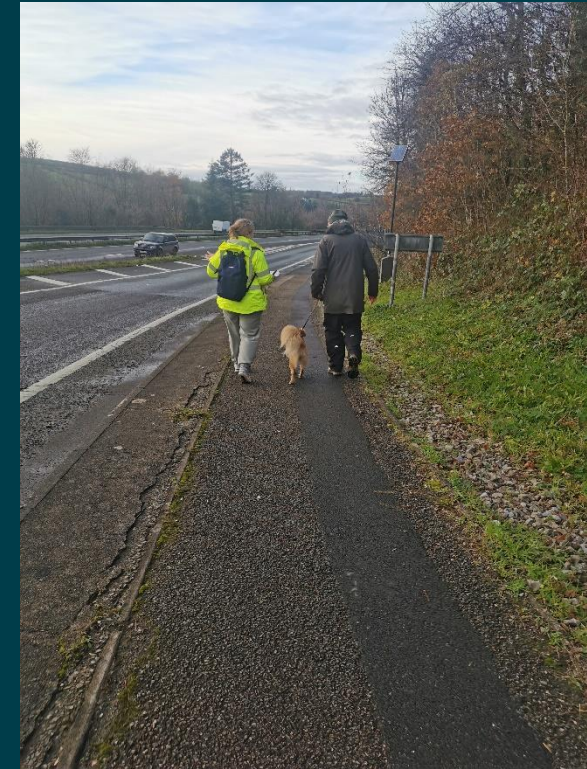
“I would like it if they were to put some of that quiet tarmac down here, so that I don’t hear the noise go past.” (Walker, Accompanied Journey)
