Riders, Walkers, Wheelers Strategic Road Network Research South West Region: A38 Devon Expressway

March 2024

A38 Devon Expressway (Lee Mill Industrial Estate – Ivybridge)

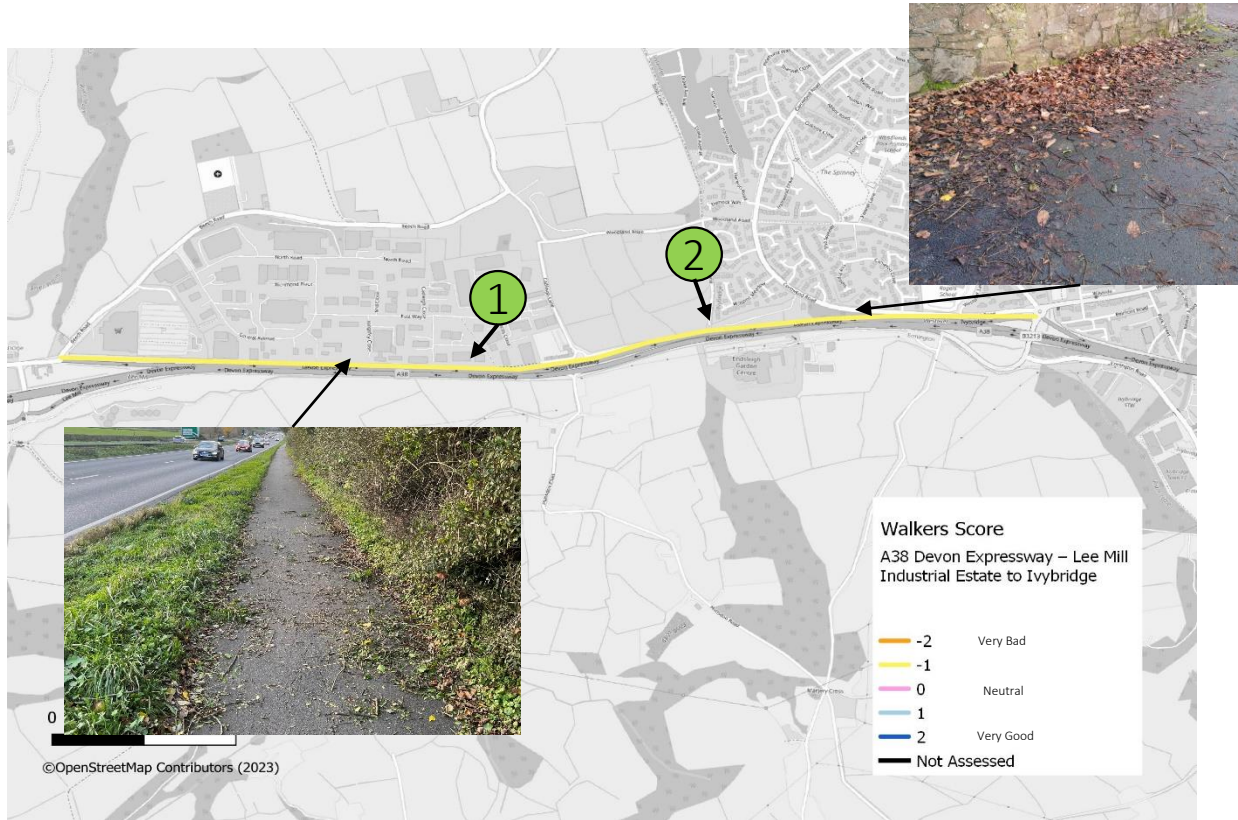
Key outcomes can be found in the table shown here. In summary, segregated shared foot and cycleways are available linking to key destinations on one side of the road only. Width of footways are below par with inconsistent surfacing. There is a lack of lighting across the site, with high levels of noise pollution present.

Link	Parameter	Provisions for walkers
1	Footway Location	Shared footway and cycleway on one side of the road, linking to Tescos (segregated)
	Footway Width	Width is between 0.8m-1.4m – should be 3m for a shared path.
	Segregation	Grass verge present
	Surface	Slippery surface in places and debris
	Lighting	Lighting towards the west, however not throughout
	Gradient	Some levels of steepness
	Wayfinding	Signage limited
	Quality	High levels of noise pollution
	Crossings	Some minor junctions present which require stop/start of the path to the east of Cadliegh Road, no tactile paving, all other access generally pedestrianised.
2	Footway Location	Shared footway and cycleway on one side of the road, linking to town centre (segregated). Accesses available on the other side of the road such as Endsleigh Garden Centre however no direct access - bridge across the B3213, however people want to use the most direct route

Footway Width	Width is between 0.8m-1.4m – should be 3m for a shared path.
	Segregation	Grass verge present
	Surface	Mostly smooth surface, but muddy in places
	Lighting	Lack of lighting
	Maintenance	Overgrown root issues
	Wayfinding	Signage at start and end of link showing link is shared
Quality	High levels of noise pollution

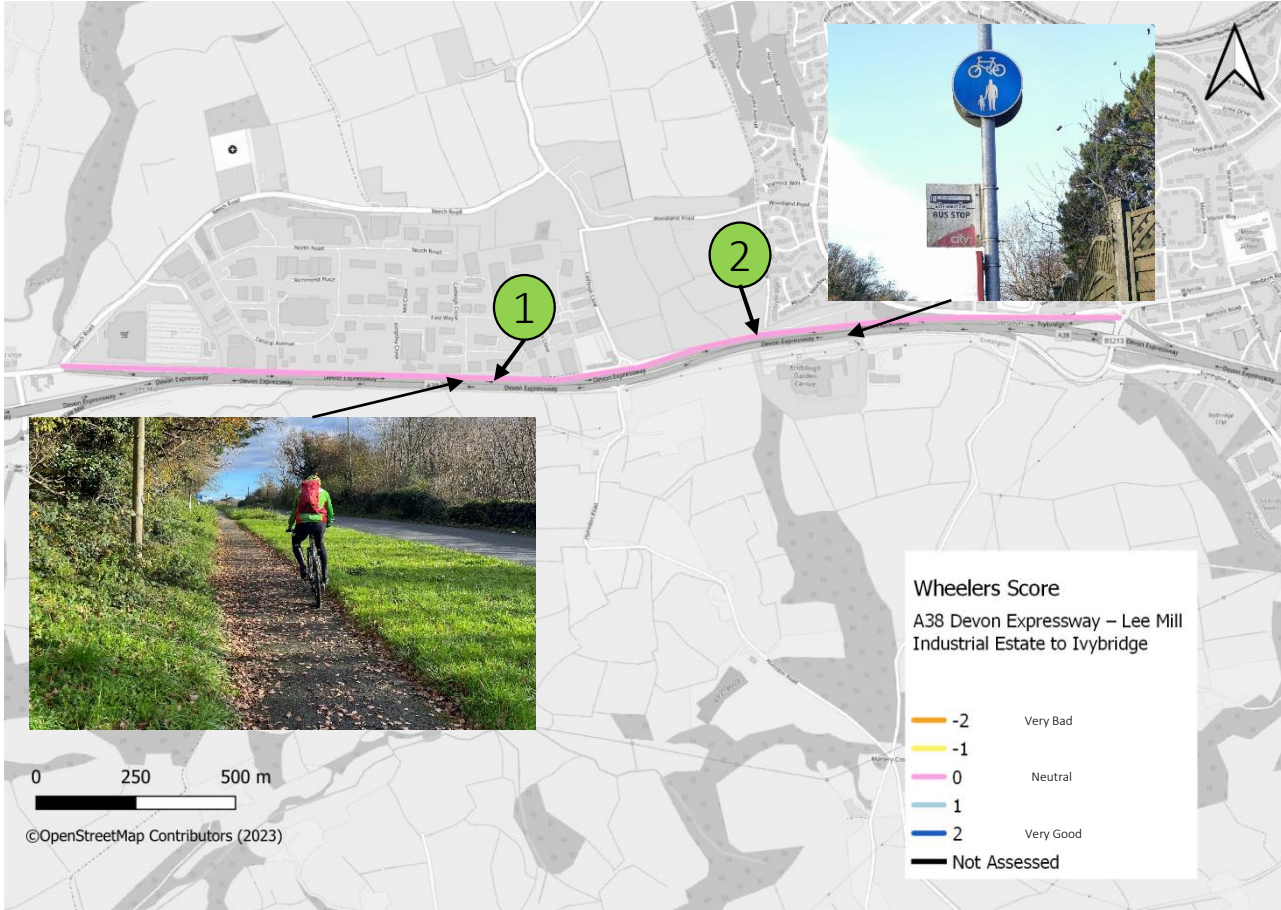
Key outcomes can be found in the table shown here. In summary, segregated shared foot and cycleways available linking to key destinations on one side of the road only. Shared path width is under par creating conflict. There is lack of lighting across the site. There is some adequate signage, however it is inconsistent in places.

Link	Parameter	Provisions for wheelers
1	Cycleway Location	Shared footway and cycleway on one side of the road, linking to Tescos (segregated)
	Cycleway Width	Width is between 0.8m-1.4m – should be 3m for a shared path.
	Segregation	Grass verge present
	Surface	Slippery surface in places and debris
	Lighting	Lack of lighting
	Wayfinding	On-road signage present, but can be unclear that path is shared
2	Junctions	Clear cycle priority at minor junctions
	Cycleway Location	Shared footway and cycleway on one side of the road, linking to town centre (segregated). Unknown if bridge is for cyclist use
	Cycleway Width	Width is between 0.8m-1.4m – should be 3m for a shared path - conflict between wheelers and walkers
	Segregation	Grass verge present
	Surface	Mostly smooth surface, but muddy in places
	Lighting	Lack of lighting
2	Maintenance	Overgrown root issues
	Wayfinding	Signage at start and end of link showing link is shared

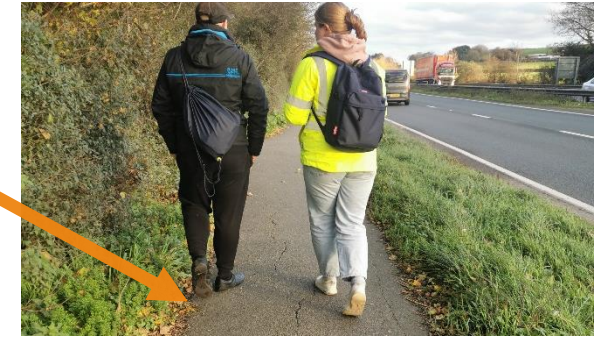
“If you slipped and fell, or hit a tree that’s hanging down, it’s quite narrow. [...] There’s not even a little wall here to stop you.” (Wheeler, Accompanied Journey)

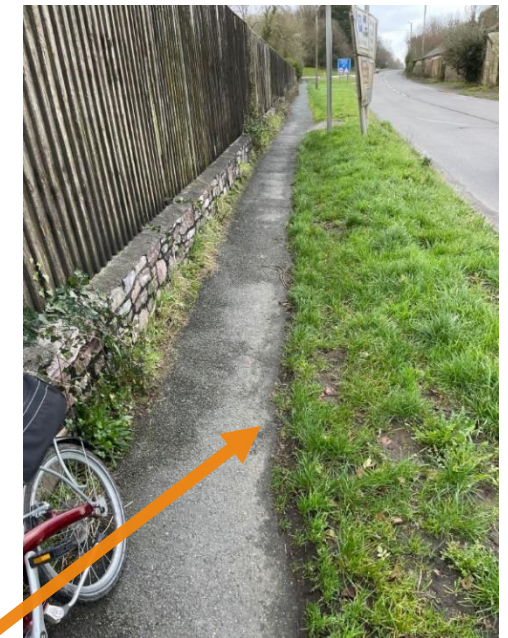
*“This isn't a *cycle path*, but a shared path, and it's FAR too narrow.” (Wheeler, Interactive Map)*

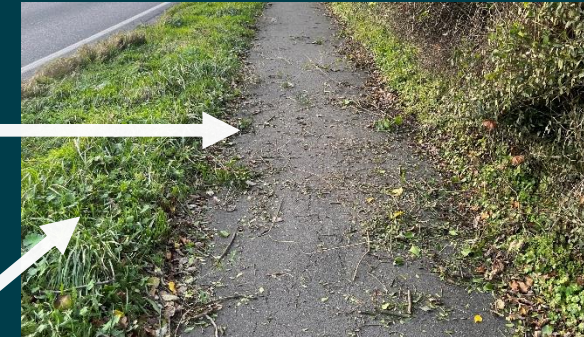
- Lack of physical barrier between wheelers and traffic can make wheelers feel unsafe.
- Narrow path leads to user conflict (see picture) – with other wheelers and walkers, particularly for those using a recumbent, due to the additional width.
- Overgrown vegetation causes hazards to wheelers, particularly overhanging trees.
- Lack of a smooth surface makes cycling more challenging.
- Car headlights obscure vision when travelling in the dark.
- Noise pollution due to proximity to the A38.
- The junction of Beech Road and New Park Road feels dangerous due parked cars causing poor visibility and fast traffic.
- Lack of segregation from traffic at the beginning of Link 1 (on Beech Road).
- Path often has litter.

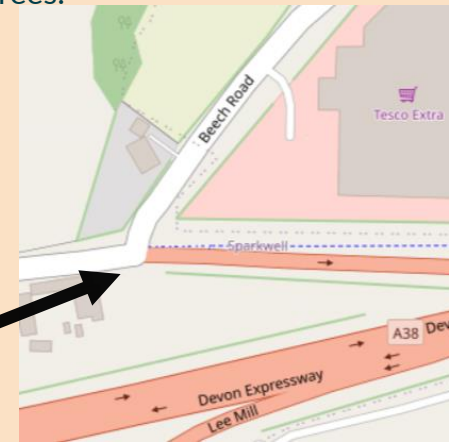
Tesco Junction (very busy)

“Every time you’re walking along here, you gotta always look out, cause you’ll always get cyclists.” (Walker, Accompanied journey)

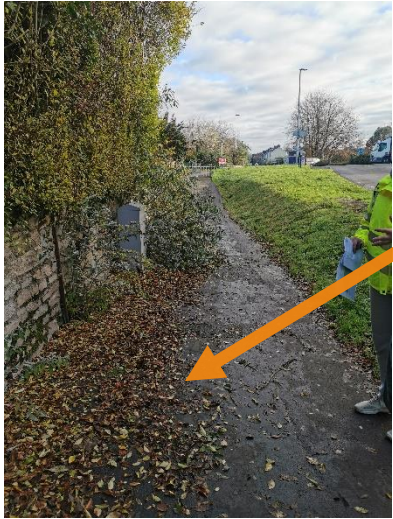
“The path isn’t the widest when its cleared but with the overhanging vegetation on one side and the ever encroaching grass on the other it get narrower each year, more frequent maintenance needed.” (Wheeler, Interactive Map)

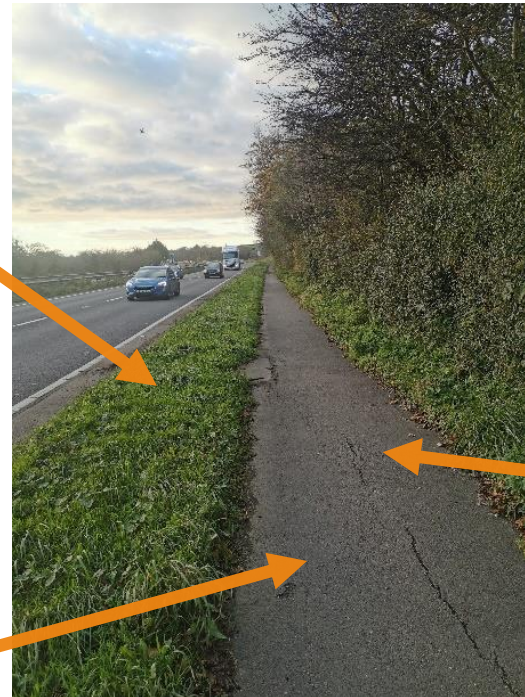
“Most of the path is narrow but particularly at end nearest Ivybridge.” (Walker, Interactive Map)

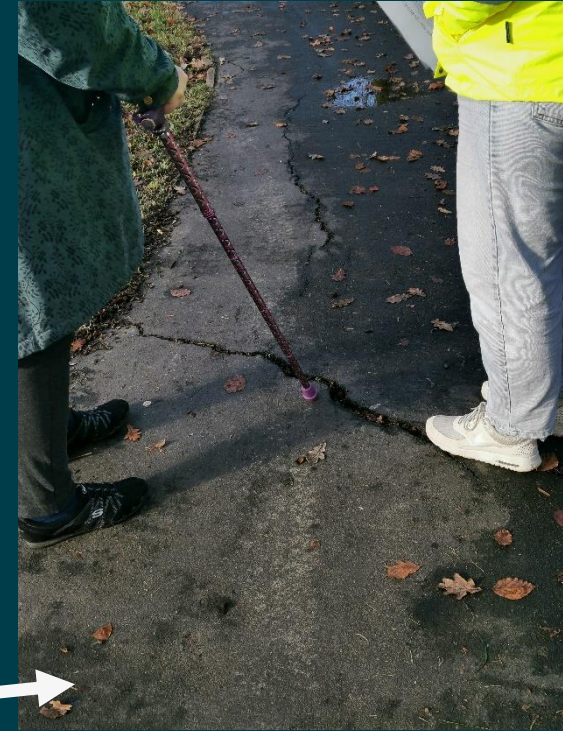
- Noise pollution makes it more difficult to hear wheelers approaching.
- Air pollution makes walking along the path unpleasant.
- Narrow path leads to user conflict with wheelers in particular, exacerbated by overgrown greenery and cars parking on the pavement.
- There is no segregation between wheelers and walkers in sections, which is a safety concern particularly when wheelers are speeding up/down the path.
- Slippery path in places due to build-up of leaves and poor drainage.
- Signage is confusing - the signage on the path surface seem to indicate the path is for wheelers only, but the bollards at the start of the path indicate it is for shared wheeler and walker use.
- Some wheelers, particularly road cyclists, do not use the path provided but instead cycle on the road, which creates conflict with cars.
- Littering on the path and poor pavement quality in places (see top picture).

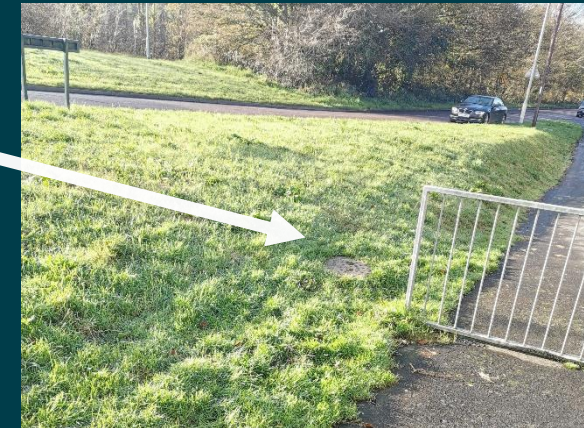
- Cycle gate at the end of Link 2 (near the roundabout; see bottom picture) is not accessible when cycling with a trailer, and does not effectively slow wheelers down as they cycle around it.
- Lack of physical barrier between wheelers and traffic can make wheelers feel unsafe.
- Narrow path leads to user conflict – with other wheelers and walkers, particularly for those using a recumbent, due to the additional width.
- Overgrown vegetation causes hazards to wheelers, particularly overhanging trees.
- Lack of a smooth surface makes cycling more challenging.
- Lack of lighting, and car headlights obscure vision when travelling in the dark.
- Noise pollution due to proximity to the A38.

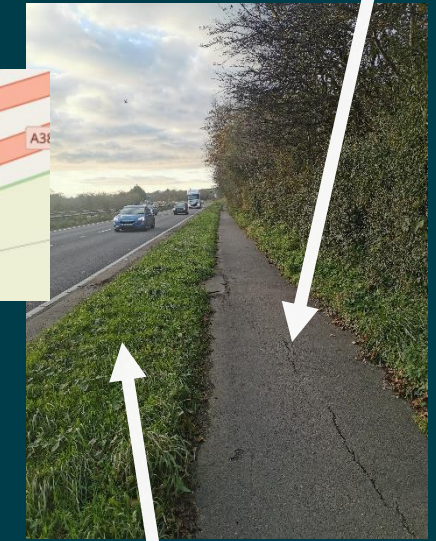
"If there was a fence there [referring to a segregation between the path and the A38], I mean ideally there would be some sort of fence." (Wheeler, Accompanied journey)
