Building accessibility into the redevelopment of Birmingham New Street station

November 2009

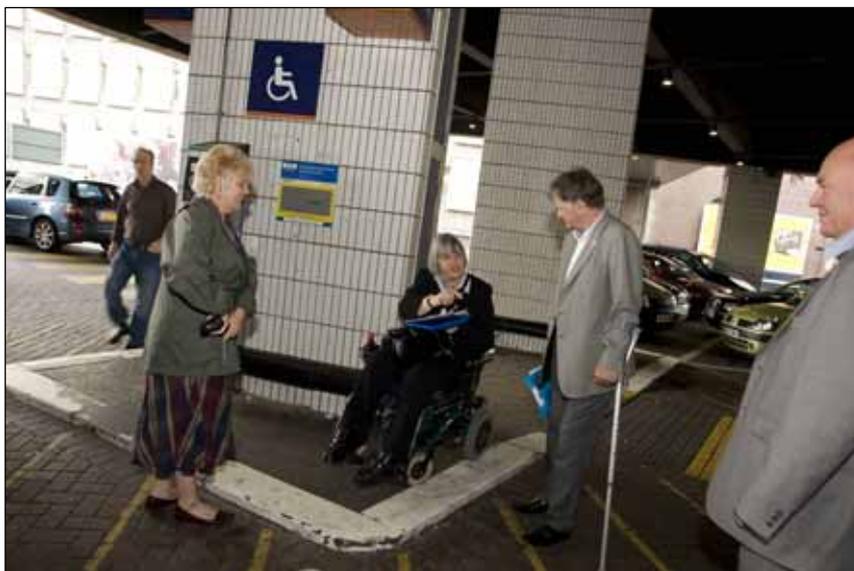
Neither entrance to the station is completely step-free – the front entrance has a single step from the car-park area and the rear entrance has several steps to negotiate. Drop kerbs are provided at the front entrance but it was felt these are in an illogical order.

Arriving at the front entrance to the station is likely to be a challenge for passengers who are sight-impaired. The ability to orientate oneself with the entrance doors was difficult because of the general noise, hustle and bustle in the drop-off

/ taxi area. With the main station doors closed it was not possible to hear the internal “sounds of the station” which would give someone who is sight-impaired an indication of where the doors are.

There are zebra crossings in this area but as they were painted yellow it was not clear who had priority when using them. General signage in this area was also very poor.

- continue to work with the RNIB to consider ways to improve orientation for visually-impaired passengers using the station (for example, a system to provide aural indication by doors and key aspects of the station)
- ensure entrances are step-free where possible and provide drop kerbs at the station entrance
- ensure zebra crossings conform to standards to ensure appropriate use
- improve signage.

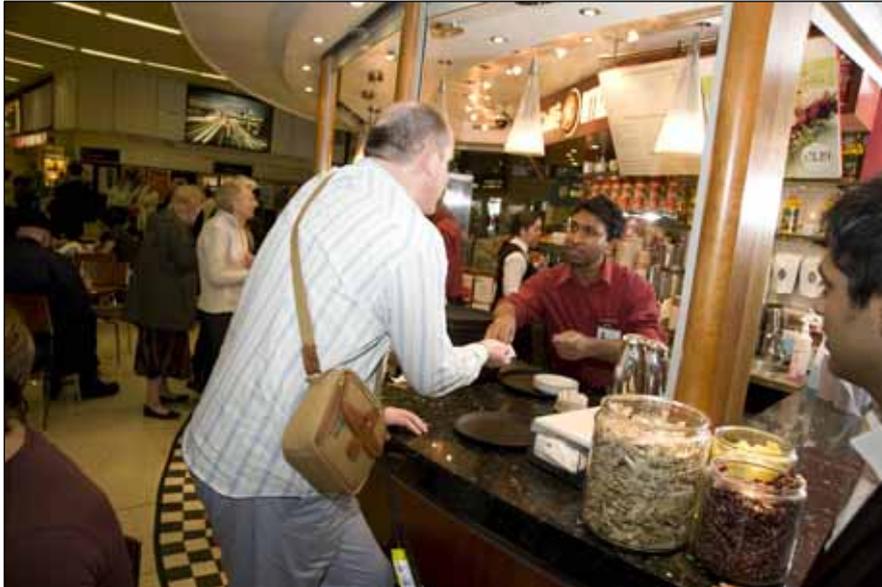
The seating area around the cafe is fenced with portable fence panels. This type of barrier prevents assistance dogs from walking under it and was deemed suitable. However, the entrance between the fencing to the coffee shop was at the wrong end of the queue which caused one of our blind volunteers to approach the counter at the wrong end. This appeared

to upset other customers and also meant that other customers had to negotiate around our volunteer and assistance dog whilst carrying hot drinks in a relatively cramped space due to the position of the tables at the counter end.

Whilst the tables were very close together, there was

room for a wheelchair and our user was able to access the cafe without too much difficulty.

- provide additional passenger seating areas on the station concourse, both sides of the ticket barriers. This should be accessible and DDA compliant
- businesses based on the station should train their staff in disability awareness
- reduce clutter / improve spacing between tables
- ensure announcements can be heard clearly in all areas of the station.

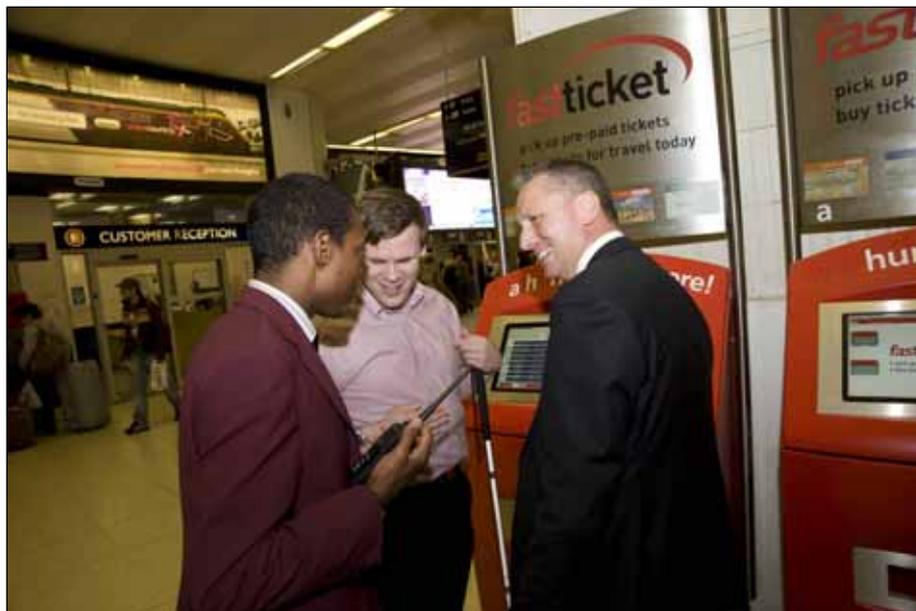
It was felt that the ticket machines were located in the right place. Whilst they are easy to use for anyone without sight-impairment, the touch screen made them inaccessible for anyone who is blind. Our assistance dog user was unable to locate where the ticket machines are as they are relatively silent when used.

Nor were the machines completely accessible for anyone who uses a wheelchair – the main display was accessible and within reach but it was not possible to see the smaller card

payment screen as it was too high. This meant that it was not possible to use the machine to pay by card and our volunteer had to abandon the transaction and go to the ticket office.

- continue to work with the RNIB to consider ways to improve orientation for visually-impaired passengers using the station (for example, a system to provide aural indication by ticket machines and key aspects of the station)
- ensure ticket machines are tactile and can be used by those who are sight-impaired
- ensure machines are at correct height to allow full use of the facilities they offer
- provide the necessary tickets requested for disabled passengers and companion.
