Riders, Walkers, Wheelers Strategic Road Network Research South West Region: A30 Bodmin-Trewint

March 2024

A30 Bodmin – Trewint

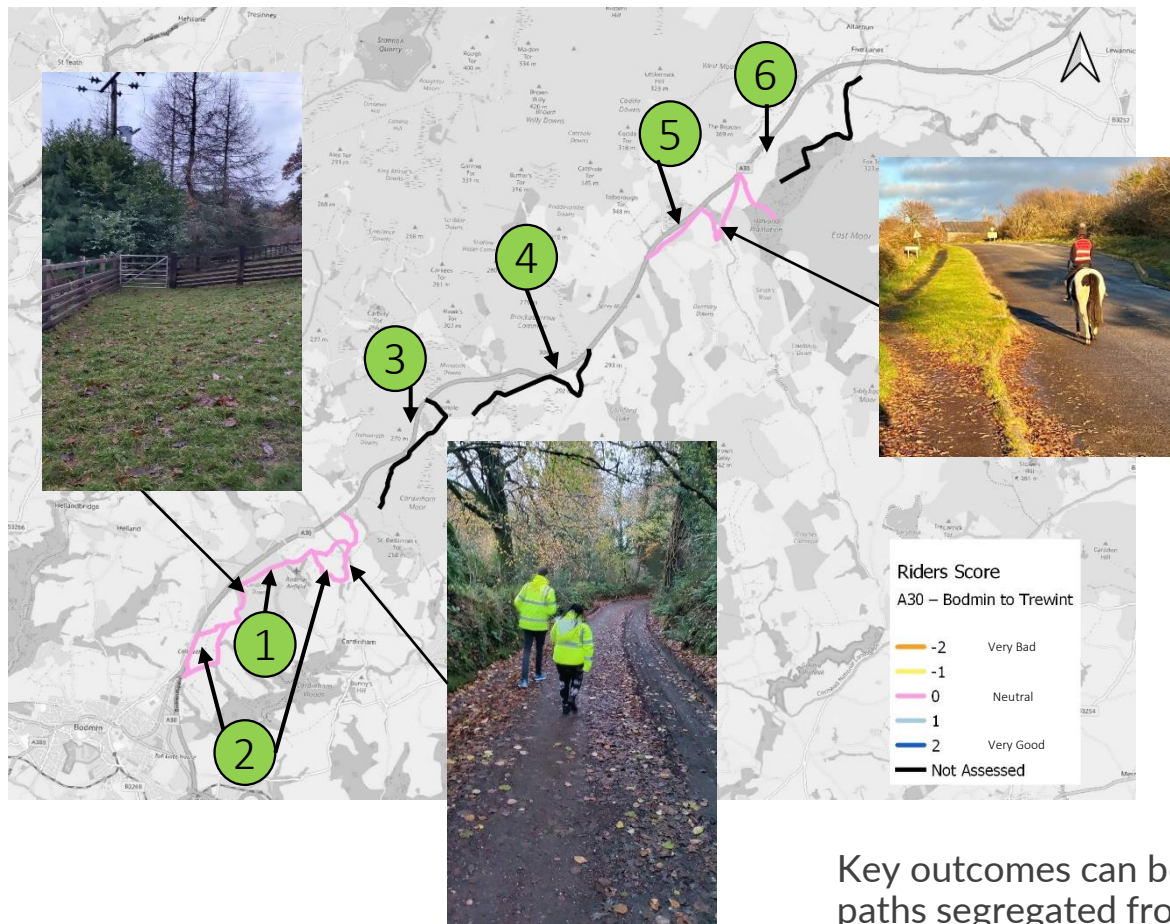
Key outcomes can be found in the table shown here. In summary, whilst Links 1 and 2 have paths segregated from the road, there is no signage indicating riders can use the paths. Riders share the road with traffic for links 5 and 6, with generally enough space for two riders to pass another rider or vehicle. Surfaces are generally flat, with some areas of steepness.

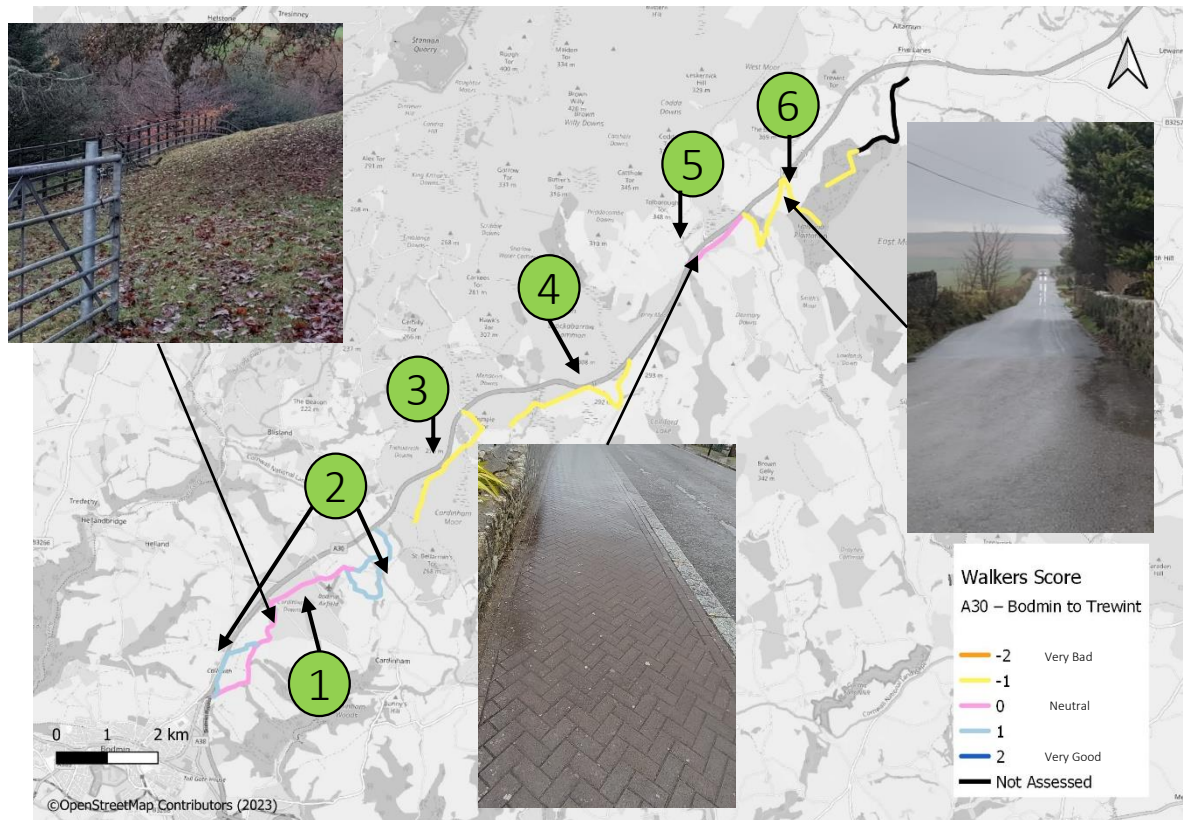
Key outcomes can be found in the table shown here. In summary, infrastructure for walkers varies across this site. Links 4 and 6 have no infrastructure for walkers, who share the route with road traffic. Links 1 and 2 have off-road segregated routes, whilst the infrastructure for Links 3 and 5 are inconsistent. There is a lack of lighting¹ and signage across site.

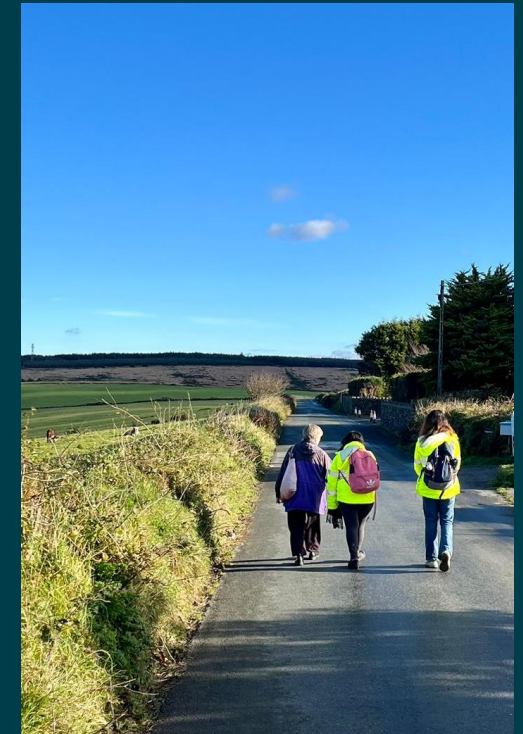
- Lack of sufficient footpaths and footways around the area (see picture) means walkers often travel on the road alongside general traffic. This can be a cause of concern, especially because of:
 - Overgrown vegetation;
 - Lack of safe crossing points;
 - The risk of silent electrical vehicles approaching from behind;
 - Lack of lighting, especially concerning for travel during the dark due to the areas secluded nature¹; and
 - Lack of visibility on corners and in poor weather.
- Limited recreational spaces for children around the Jamacia Inn also mean children often play on the roads, exacerbating these concerns.
- Walking does not appear to be positively encouraged around the local area, as there is:
 - Poor phone signal for navigation; and
 - A scarcity of benches and shelters along the route.

“The vegetation [in the footways] is getting so overgrown there’s hardly any space for me to walk” (Walker, Accompanied Journey)

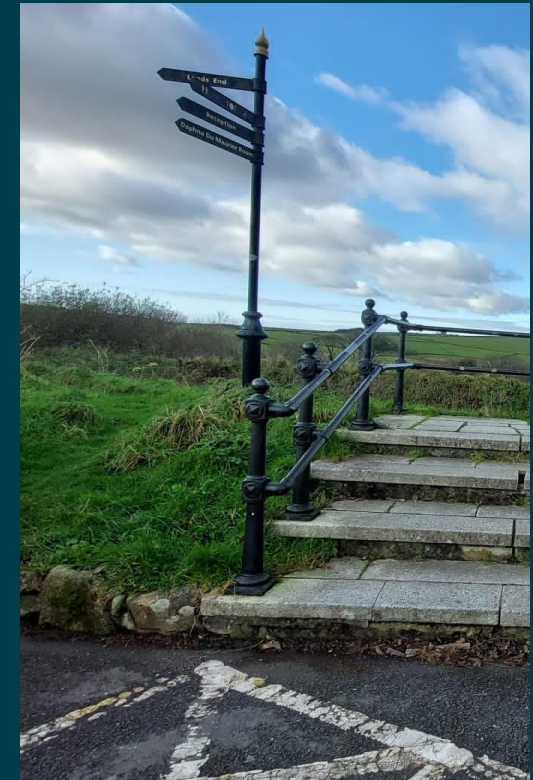
- The links are a part of many routes for walkers, so local businesses see customers and employees use the route extensively for walking and cycling.
- Sufficient space on available footpaths and roads, with an even gradient, and good quality of surface.
- Good signage for pedestrian visitors (see picture).
