Walkers, Wheelers, Cyclists, Horse-Riders

Strategic Road Network Research

North West Region

February 2025

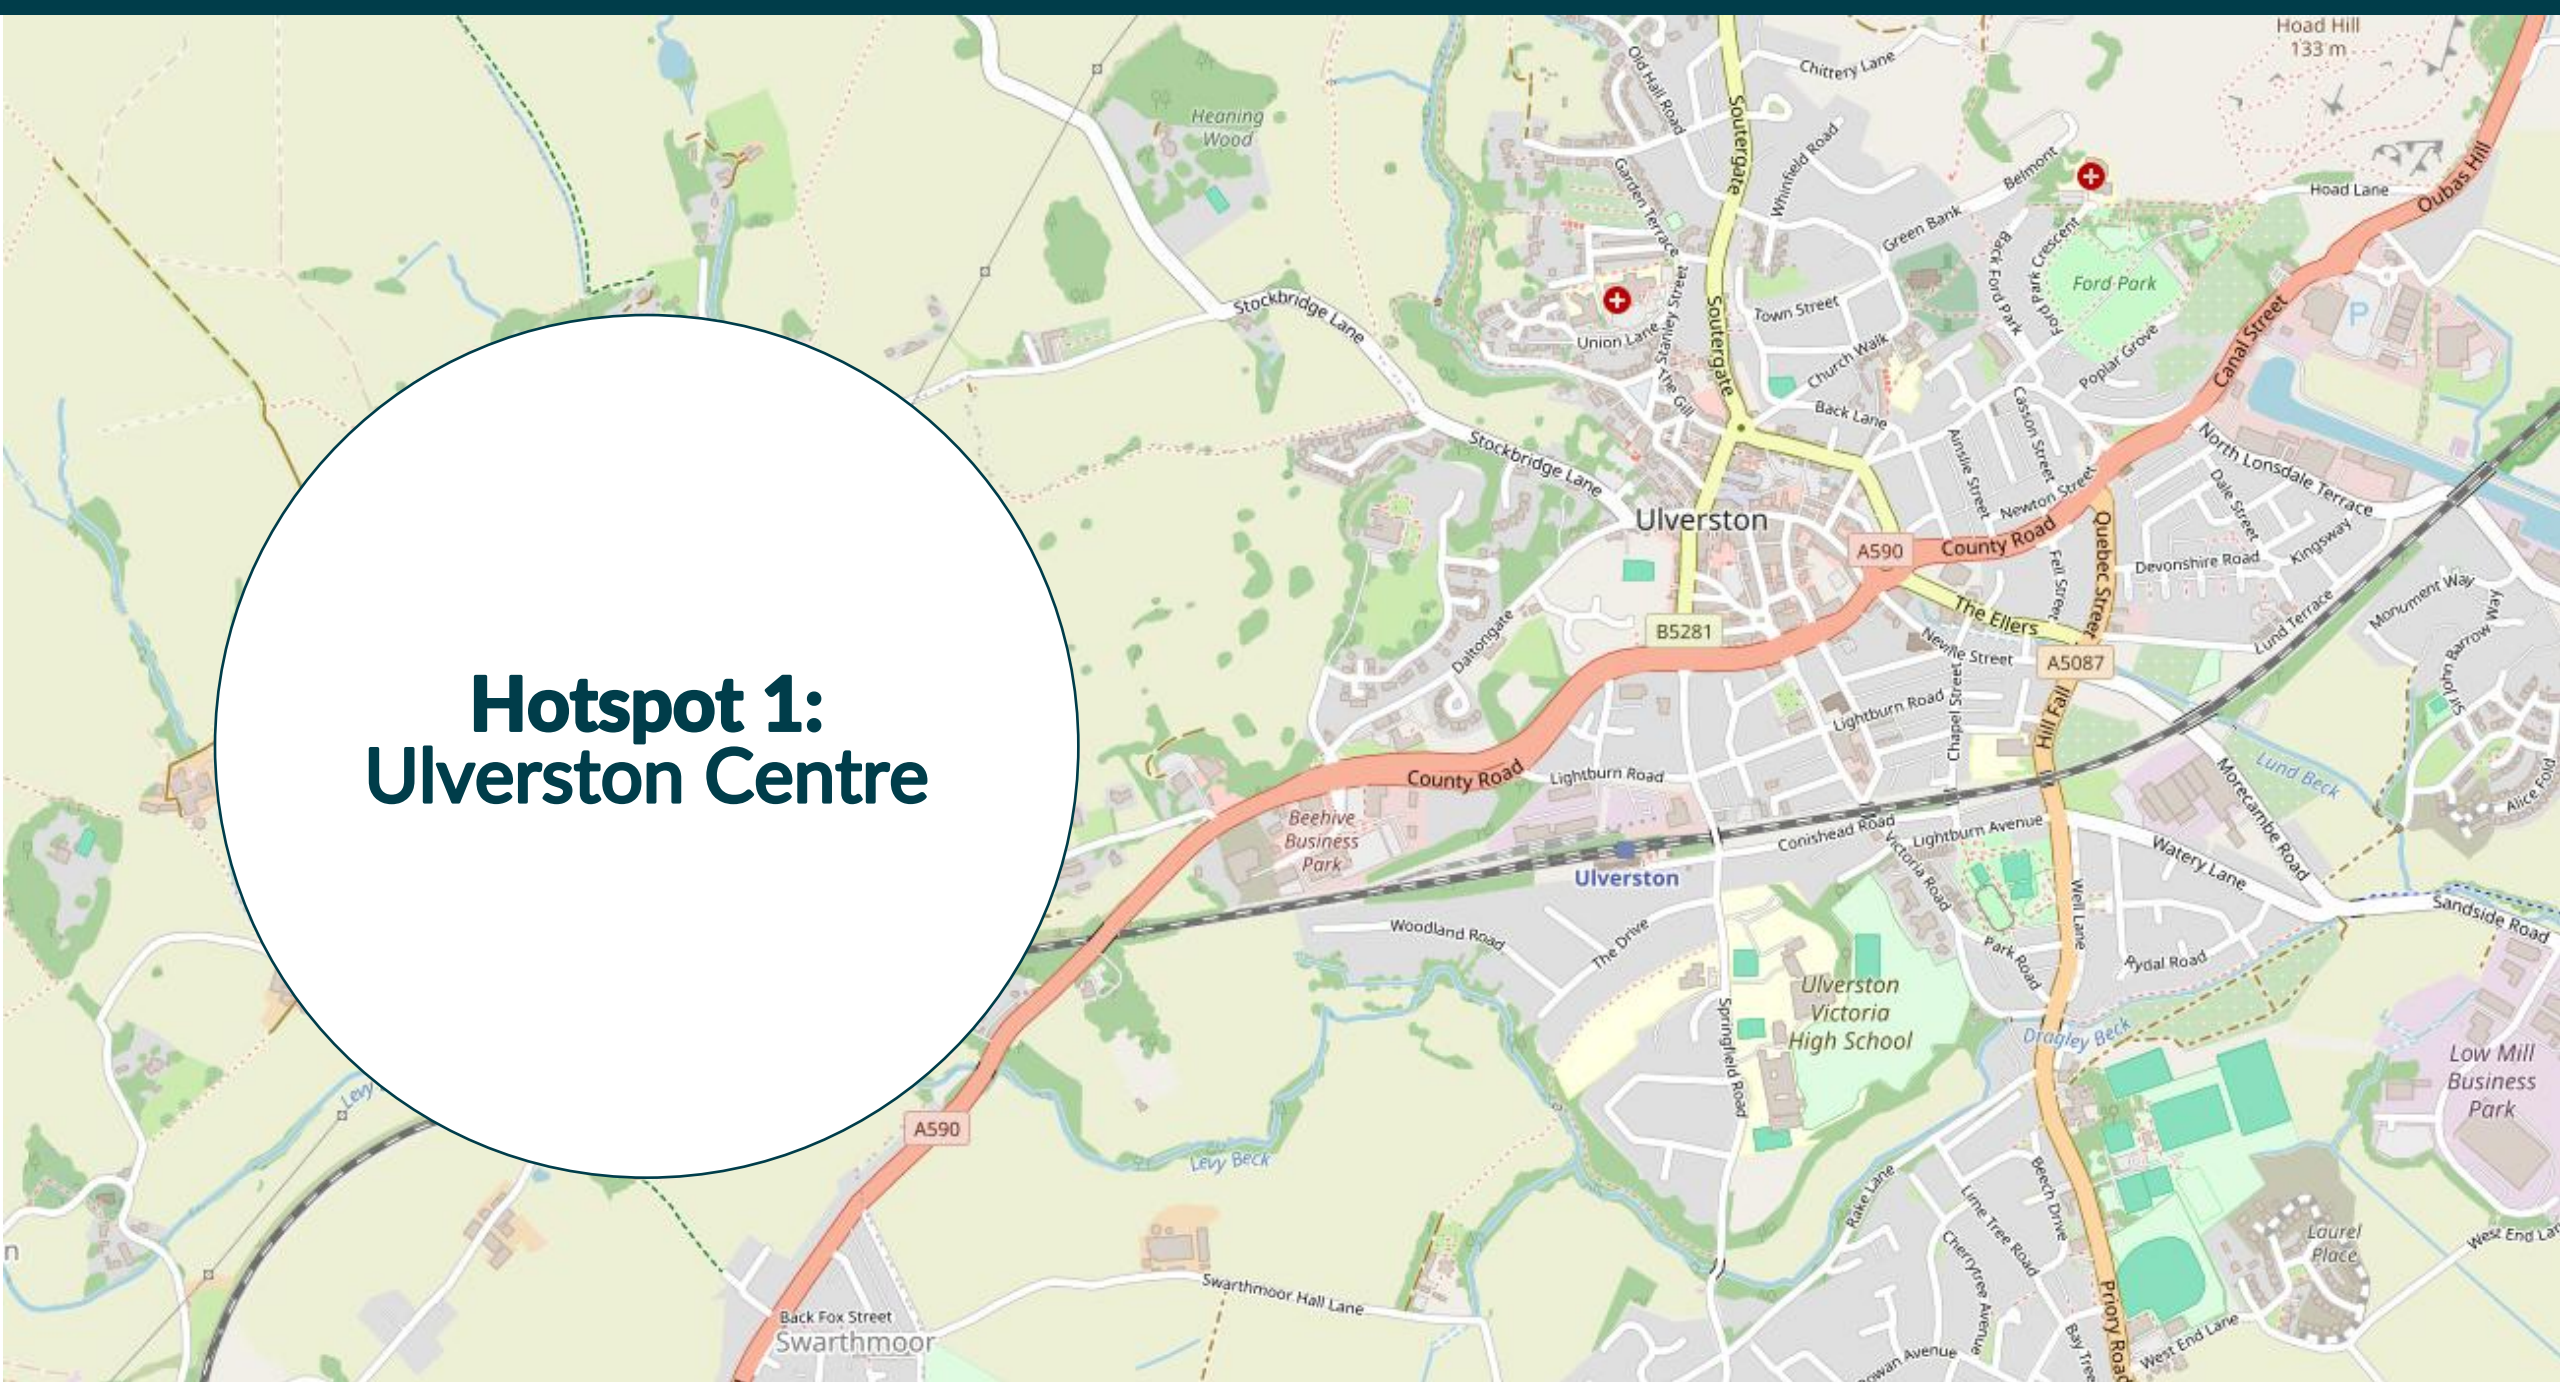
Hotspot 1: Ulverston Centre

To the north of Ulverston, the SRN (Link 4 on map) becomes dual and single carriageway, with cyclists known to travel on this route to connect with cycle routes up to Haverthwaite.

This hotspot was split into **five** separate sections ('links') for this research (see map).

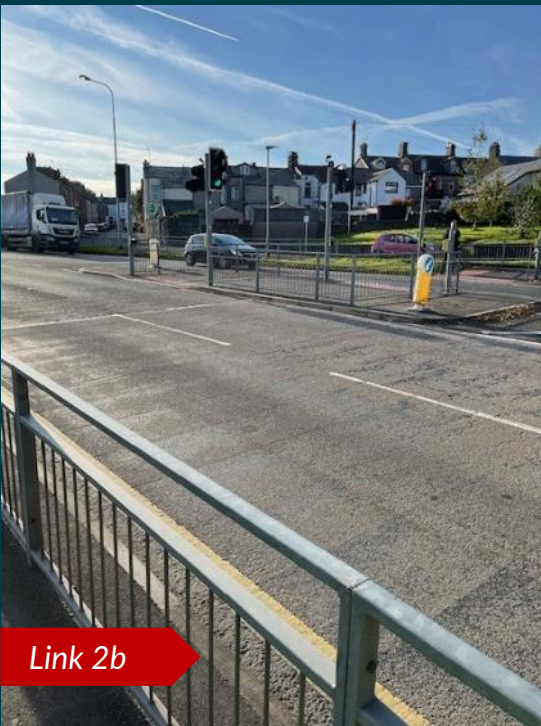
Link 2b

"The crossing waits sometimes feel too long... Mum's back can't handle standing there forever." (Walker)

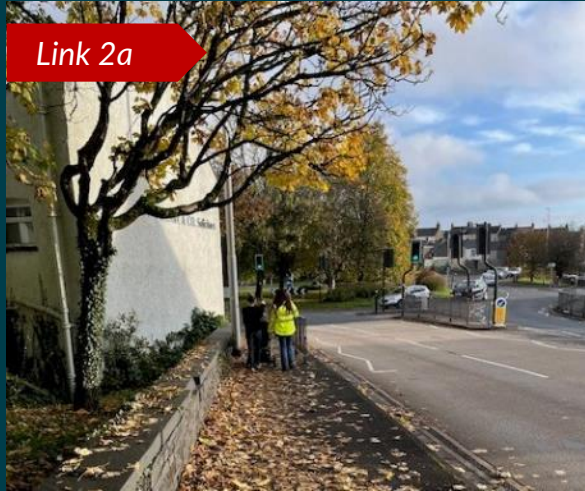
Link 2a

"When [the A590] is really busy, it's a bit **dangerous**." (Walker)

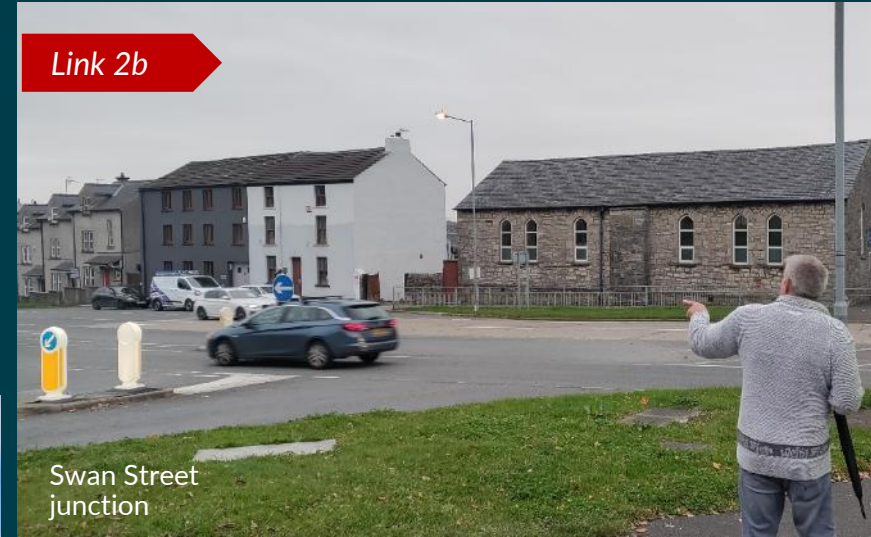
Link 2b

Swan Street junction

"The A590 route through the town centre suffers from putting the motor vehicle capacity above all other design considerations making it difficult and unattractive for pedestrians and cyclists." (walker and Cyclist)

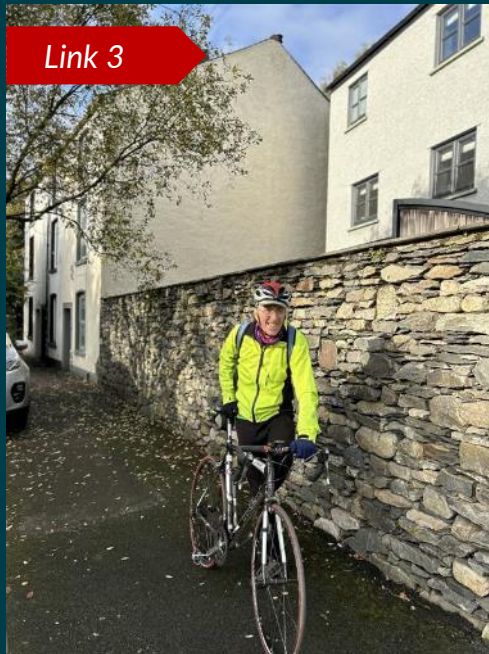
Link 3

"I go in the way south of Ulverston several times a week, but I don't go north of Ulverston because the A590 is very dangerous and the alternative is extremely hilly. I tend to do that only once a week." (Cyclist)

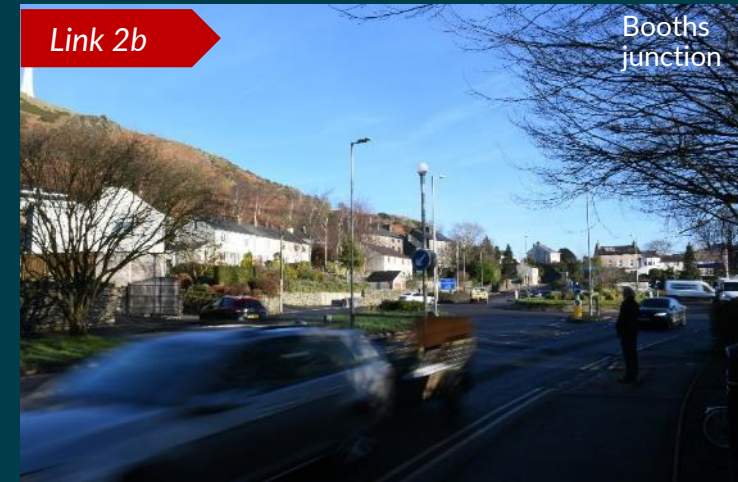
Link 2b

Booths junction

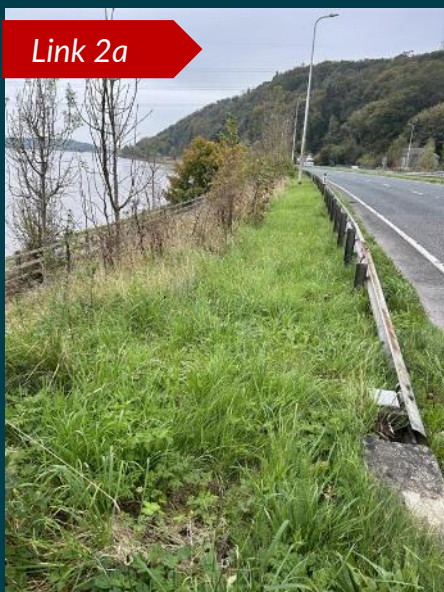
Link 2a

"The little one metre strip is going narrower and narrower and disappearing again, just before the roundabout, forcing you into the traffic flow." (Cyclist)

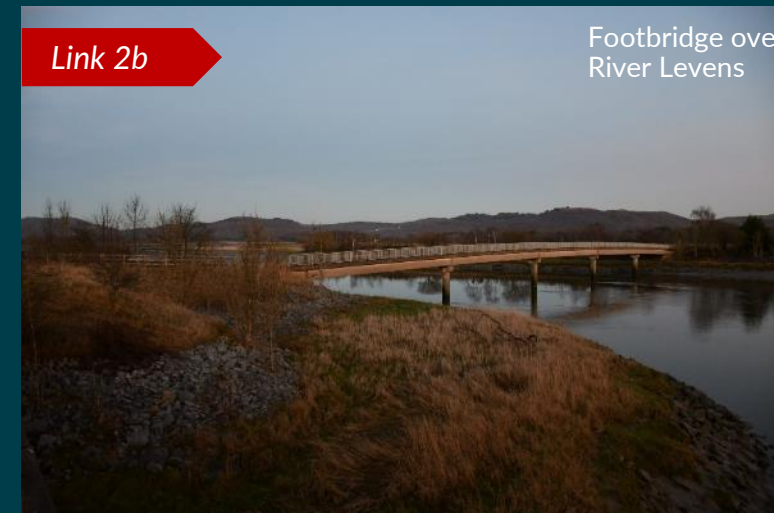
Link 2b

Footbridge over River Levens

"This bridge over the river takes you on to where the Cumbria cycleway goes... that track the other side of the bridge, is quite rough and it floods a lot, so it's somewhat problematic for cyclists... you have to climb over the barrier... there's no way through." (Cyclist)

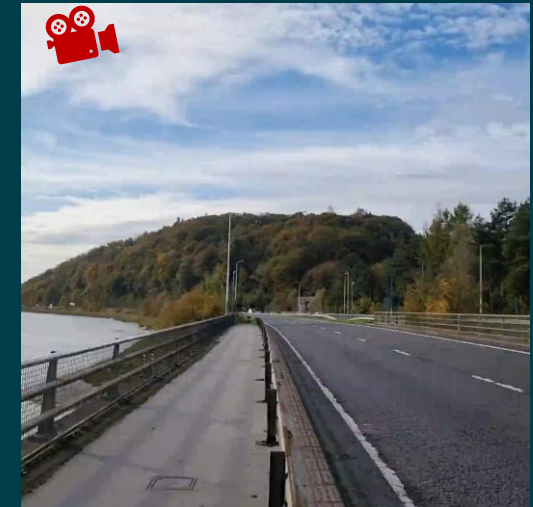
"This bridge over the river takes you on to where the Cumbria cycleway goes... that track the other side of the bridge, is quite rough and it floods a lot, so it's somewhat problematic for cyclists... you have to climb over the barrier... there's no way through." (Cyclist)

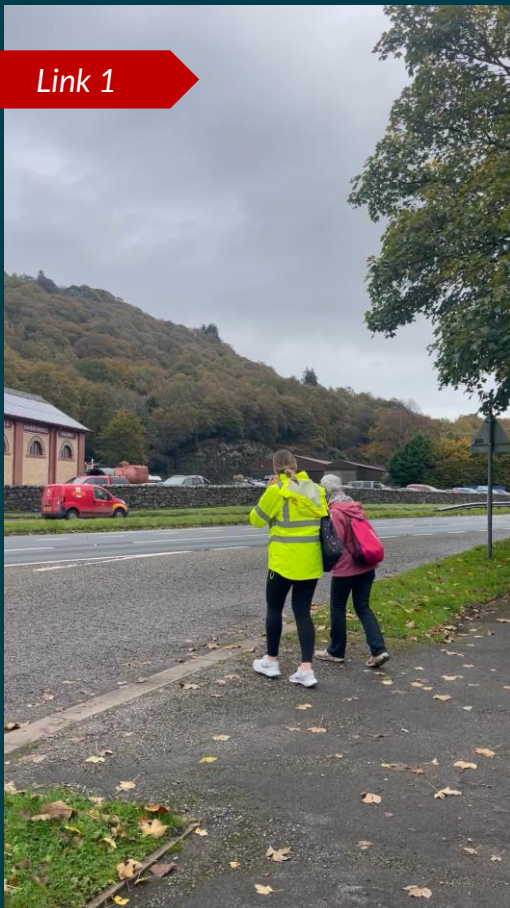
Link 1

"There isn't much at all good for walkers in this section of the A590, there's not much in the way of continuous paving... I think anywhere where there is a busy road, people would prefer to not be near the road because of traffic and fumes and noise and everything else. We just try to use it as an artery to get to the main location." (Walker)

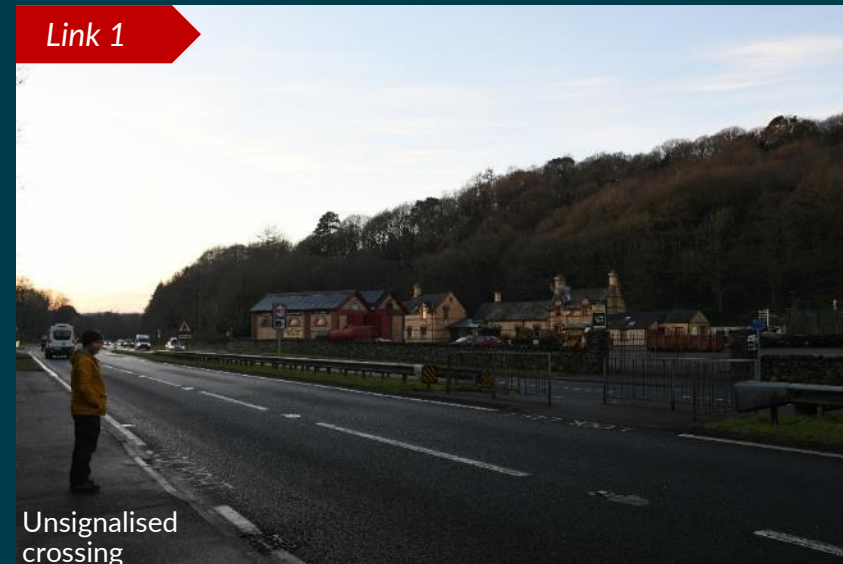
Unsignalised crossing

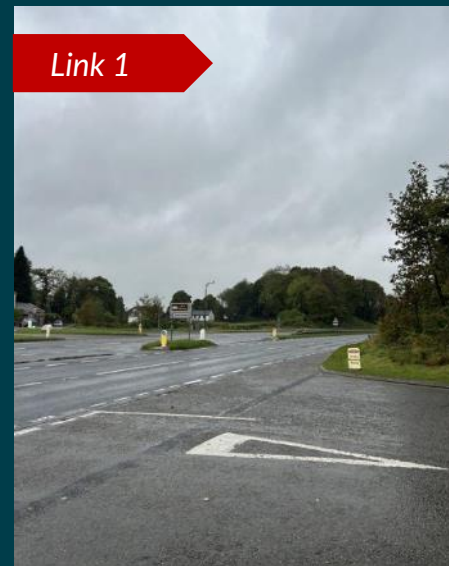
Link 1

"I wouldn't do it in the dark, no there's no streetlights. Only the odd one. We wouldn't want to go walking in the dark, we wouldn't see anything in the dark." (Walker)

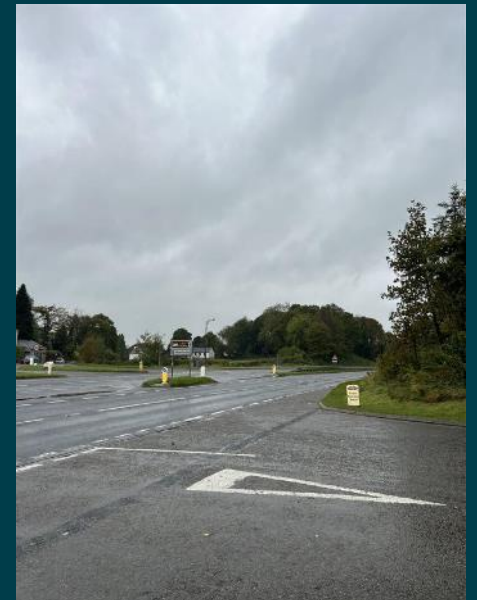
"We sometimes use the [Haverthwaite] crossing, but it depends on which direction we are walking. We crossed here[at the railway cross roads] because it's just more direct, and we can use the grass as an island to help cross."
(Walker)

"You've got to be careful, and look out for any cars turning left off the A590 [at the railway cross roads]...As long as you've got your wits about you and you're looking all around it's fine."
(Walker)

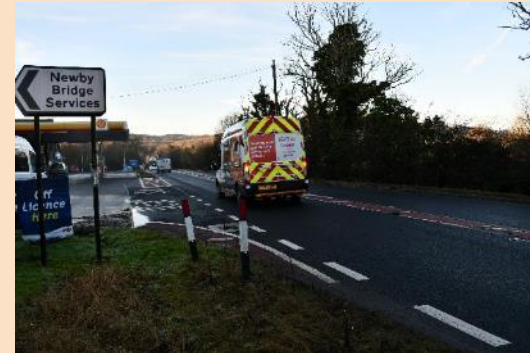
- Lack of footways along Link 1 and Link 5 results in people avoiding the link or having to walk on the road (A590) itself, which is dangerous and has fast-moving traffic. To note, the Shell garage on link 5 provides the nearest local shop for some residents and lacks walker access.
- Fast-moving traffic and poor visibility near junctions, crossings and Newby Bridge roundabout pose a significant risk, especially for elderly walkers.
- Cyclists sharing paths can make walking more feel uncomfortable.

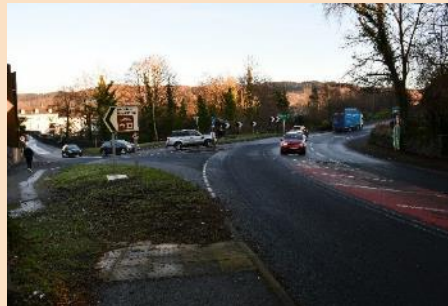
- Fast-moving traffic and poor visibility near junctions, crossings and Newby Bridge roundabout pose a significant risk, especially at the Newby Bridge and Newby Bridge Hotel junctions. Therefore, wheelers often have to wait a long time to cross the A590 safely.

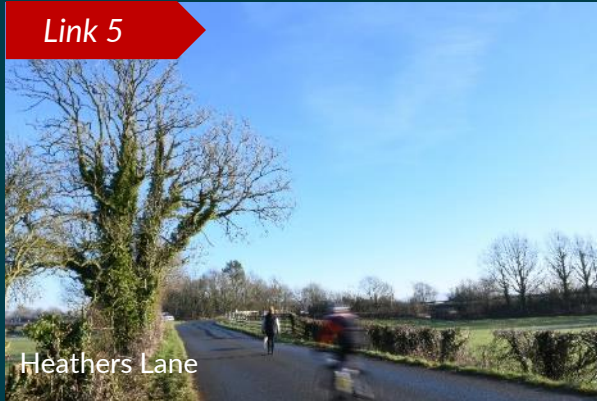
Link 5

Heathers Lane

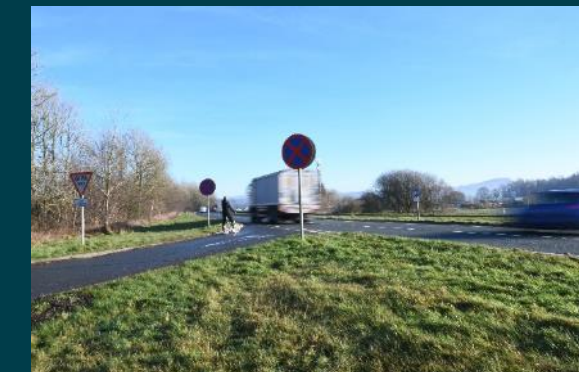
"The National Cycle Network route 700 passes under the SRN [at Levens Lane], with traffic coming off the busy slip road. There is inconsistent and non-existent footway in both directions, and the footway runs out underneath the SRN underpass, stranding walkers." (Cyclist)
