# **What do walkers, wheelers, cyclists and horse riders want from National Highways?**

Case study: A590, South Cumbria

May 2025

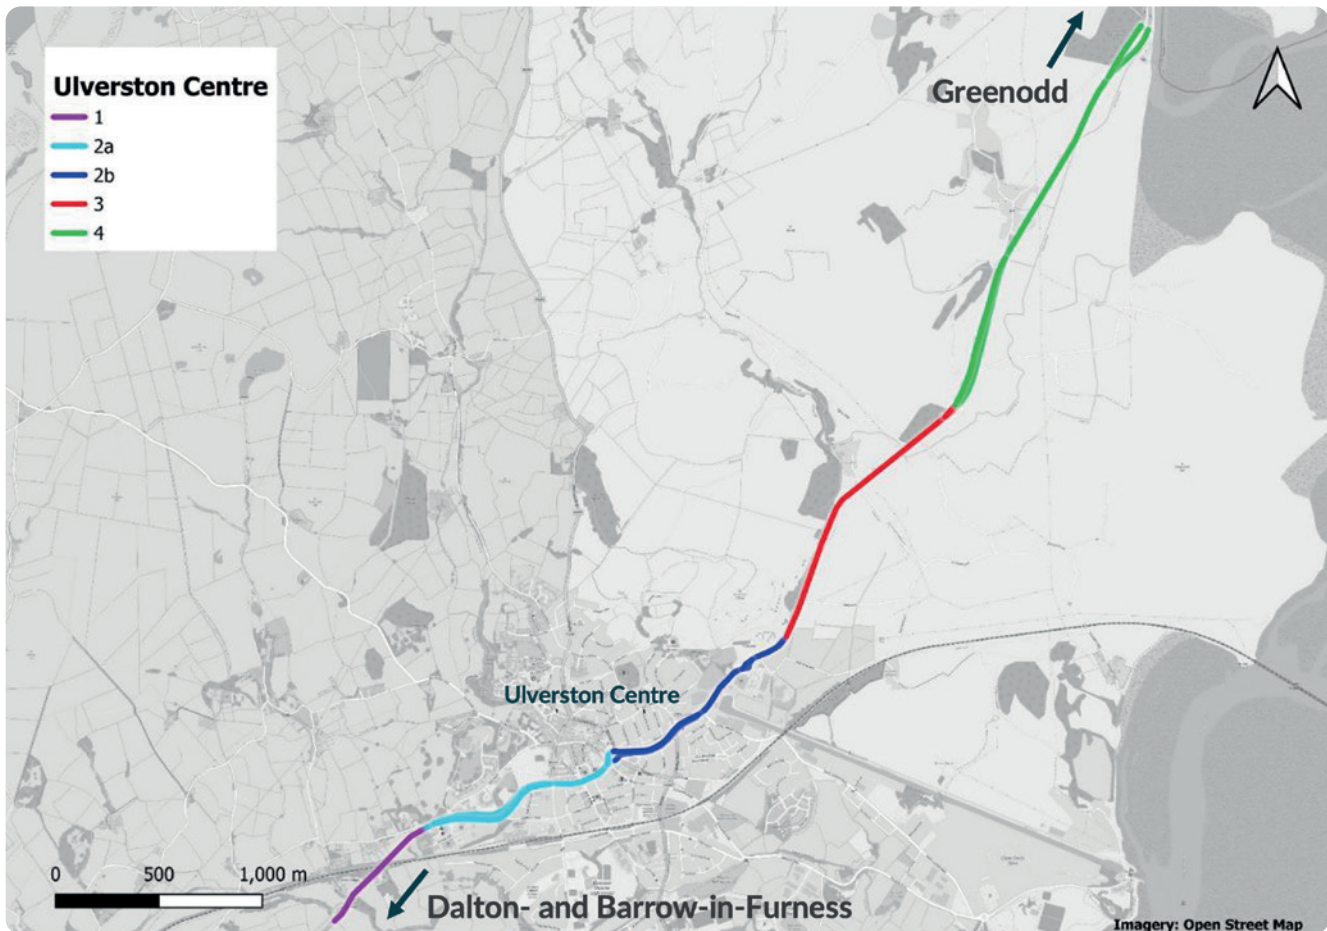
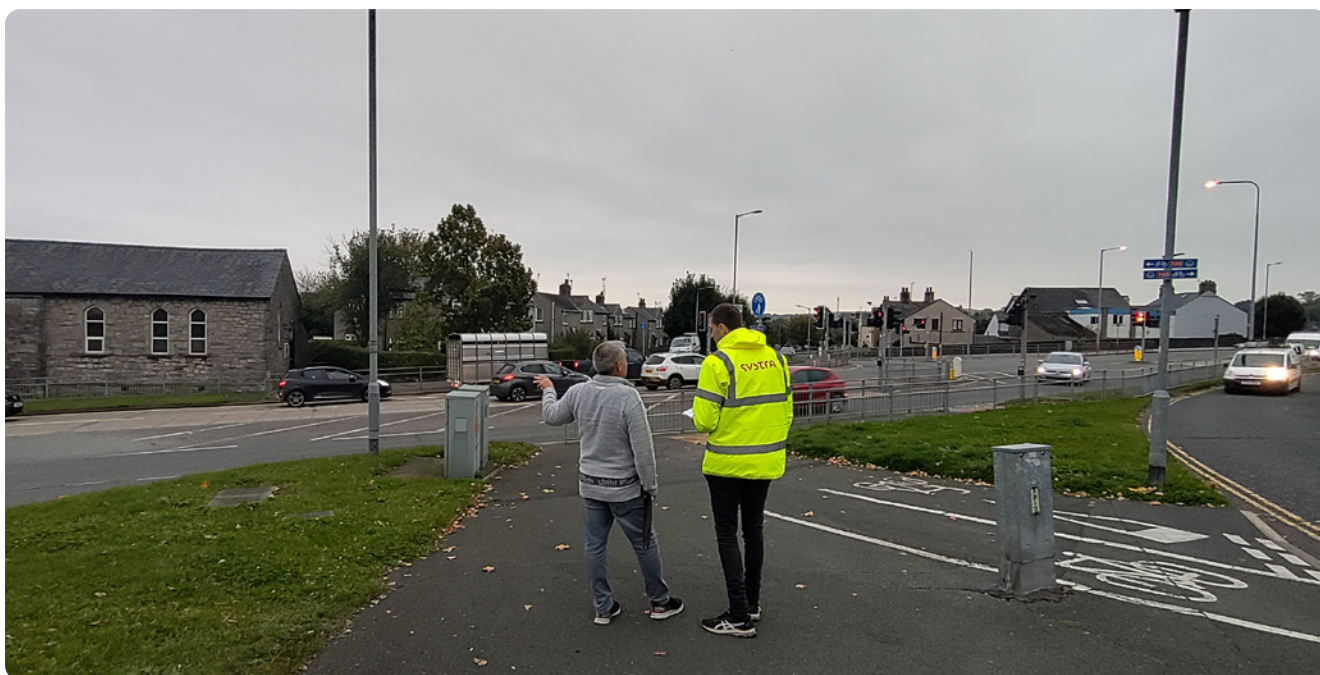
Ulverston is a major town within the Furness Peninsular. The A590 runs through the centre of the town, meaning that interaction with the road is common for residents. To the north of Ulverston some sections of the A590 become dual carriageway. Cyclists are known to use this route to connect with Haverthwaite. For the purposes of the research, the location was divided into five sections:

- **Section 1** – from the south to the Pennington Lane junction.
- **Section 2a** – from the Pennington Lane junction to the Market Street/The Ellers roundabout.
- **Section 2b** – from the Markey Street/The Ellers roundabout to Hoad Lane.
- **Section 3** – from Hoad Lane to the start of the dual carriageway.
- **Section 4** – from the start of the dual carriageway to the north towards Greenodd.
