Riders, Walkers, Wheelers Strategic Road Network Research South West Region: A38 Liskeard

March 2024

This report provides findings for the following location: **A38 Liskeard (Old Road Junction – Lantoom Quarry)**. The report is structured as follows:

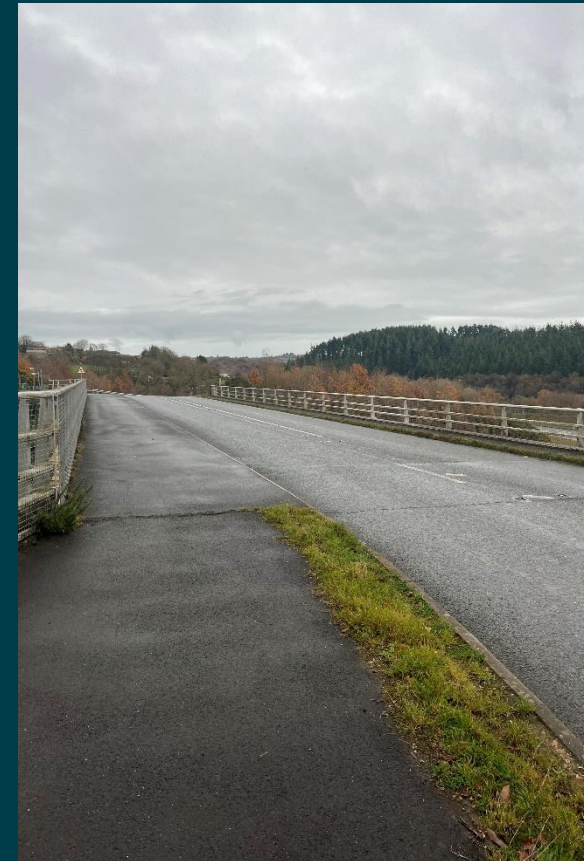
- The path at the top of the Dobwalls Bypass is wide enough for wheelers to pass other users, without needing to slow down or dismount (see picture).

*“Up the top half, they cleared the pavement and there’s enough room now to get three abreast people. A couple can now walk together and you can cycle or walk past them.”
(Walker and Wheeler, Accompanied Journey)*

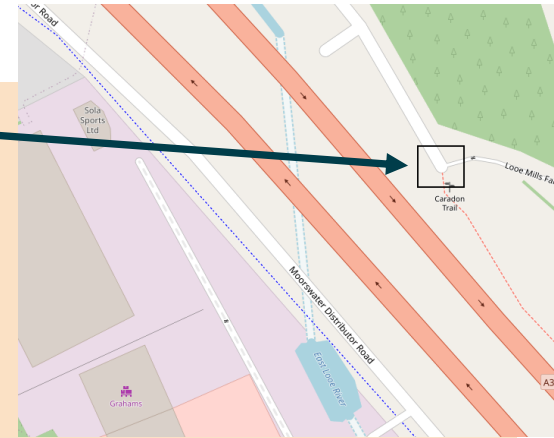
- Poor wheelchair access at the Dobwalls Bypass where Link 2 meets Link 3, due to the lack of dropped kerbs.
- Narrow paths to access the woodlands create conflict between walker and wheelers.
- Lack of lighting, though there was acknowledgement of the proximity to the traffic on the A38 and the danger that adding lights may pose to motorists.
- Lack of waste bins may be challenging for dog walkers.
- Surface quality may be fine for walkers, but challenging for walkers with prams.
- Lack of a shorter, more direct alternative route to reach the woodlands north of the Dobwalls Bypass from Liskeard town, due to landowners blocking access to bridleways and footpaths.

- Provide dropped kerbs on the paths towards Dobwalls Bypass to improve access for wheelers.

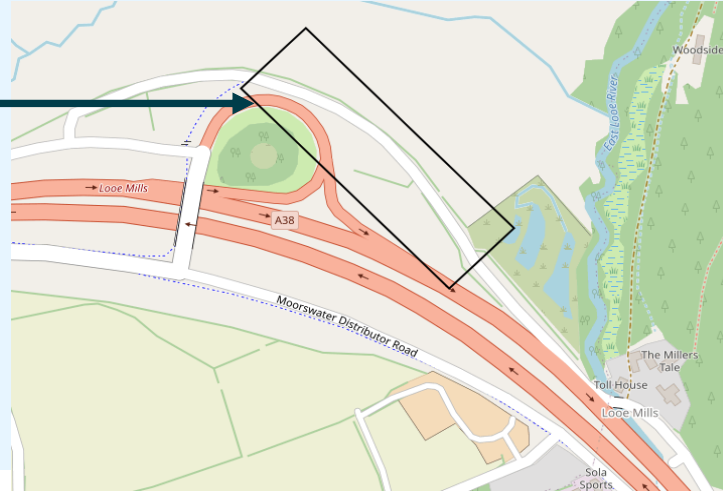
- The existing infrastructure for walkers along the link works well as it is.
- Lower noise and pollution levels on Link 2, compared to Link 3, moving up towards the Dobwalls Bypass, where the path is separated from the traffic on the A38 (see picture).
- No issues with vehicles passing by on the parts of the route where there is no pavement for walkers.

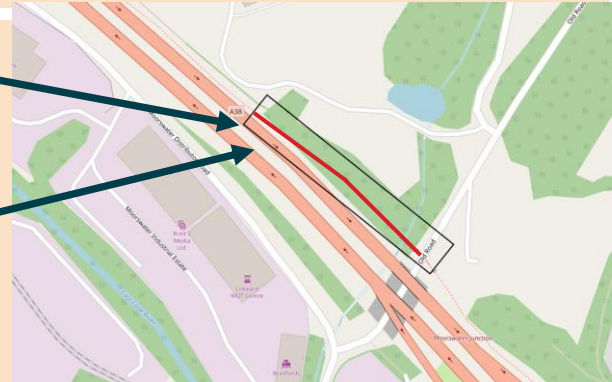
- Slippery surface and visible cracks and dips on the steps at the end of the link that accesses Old Road (see picture of steps on the right).
- Narrow shared use path at the end of the link that accesses Old Road creates conflict with wheelers, with walkers having to move out the way of wheelers.

- While not directly related to the link, concerns were raised over the lack of lighting on the footpath adjacent to the eastbound slip road onto New Road, which links up with Link 3 at Old Road, as well as the steep gradient and narrow width of the ramp, as this limits access to the path for walkers with a pram/buggy.

- Improve access to the link for wheelchair users and walkers with prams, by adding a ramp to replace the steps at Old Road.
- Improve lighting provision along the link, though some acknowledge this may be dangerous due to proximity to the A38, and may not be a priority due to the low activity along the link.

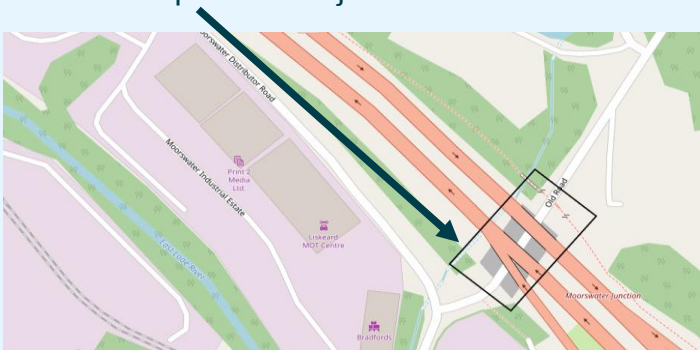
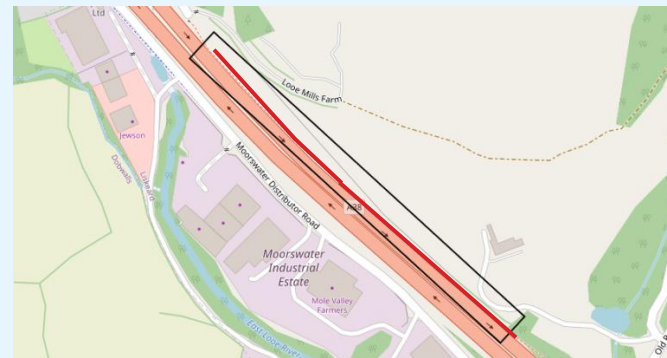
Path on the part of the link that runs directly adjacent to the A38

- The path on the part of the link that runs directly adjacent to the A38 is flat and has a good gradient and surface for wheelers, though there was acknowledgement of the limited access for wheelers to this part of the link as well (see picture).
- The path on the part of the link that runs directly adjacent to the A38 is wide and works well as a shared use path for walkers and wheelers.
- Part of the link that runs directly adjacent to the A38 get maintained twice a year, though more maintenance would be useful.
- The underpass which joins Link 3 to Link 4 is useful to cross the A38.

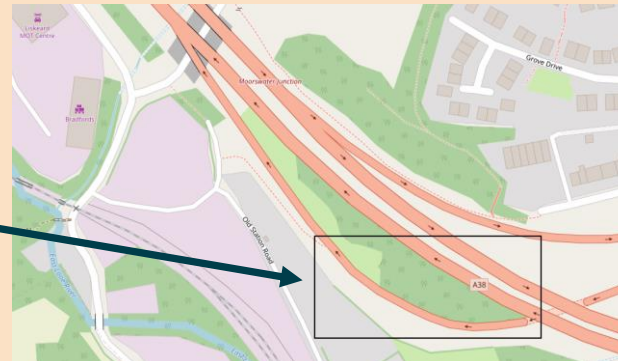
- Unsafe crossing point along the Industrial Estate where the path on one side of the road ends abruptly. There is limited visibility of oncoming vehicles, causing safety concerns, particularly for elderly and disabled walkers trying to cross the road to re-join the shared use path.

- Parked vehicles on the pavement along the Industrial Estate create conflict between walkers and wheelers, particularly due to the narrow width of the pavement.

- Lack of lighting provision at the underpass where Link 4 loops around to join Link 3.
- While not directly related to the link, feedback raised safety concerns over the lack of a shared use path along the westbound A38 slip road off of New Road, as walkers need to travel alongside fast traffic. This limits access to the link and Moorswater Industrial Estate for walkers travelling through New Road.

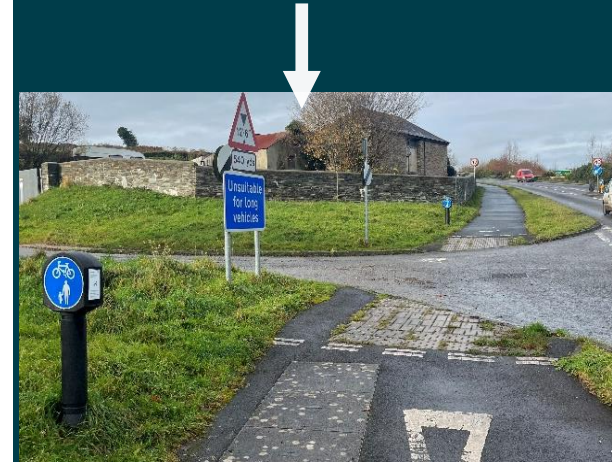
- Some employees use the path along Moorswater Industrial Estate for cycling and walking to and from work, as part of the business' Cycle to Work scheme (see picture).
- In contrast with the feedback provided by users, businesses did not report issues with lighting provision, mentioning that undertaking cycling journeys in the dark is fine when using cycle lights.

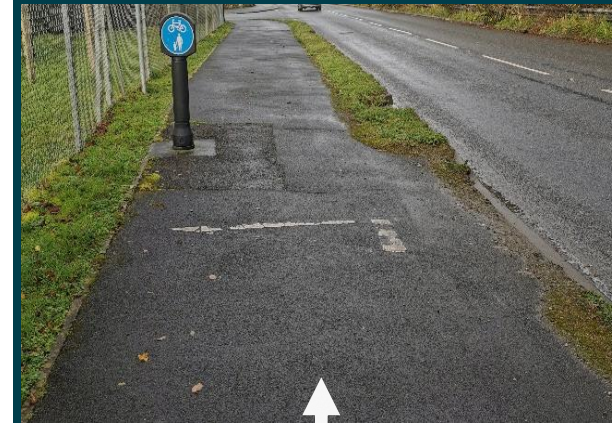
“If these steps [referring to the steps on the footpath joining Old Road from A38] were removed cyclist could get off the slip road and access moor water safely if travelling west.” (Walker, Interactive Map)

- Provide a segregated shared use path along the westbound A38 slip road, to provide safe access to the footpath by Old Station Road and Moorswater Industrial Estate, join up with the paths on the link, and improve safety for all users, as currently users have to travel next to vehicles travelling at high speeds; and
- Allow access for wheelers onto footpath coming off of the westbound A38 slip road, joining into Old Station Road, by removing the steps on this path and widening the slope down from the slip road, to make this a shared use path connecting New Road to Moorswater.

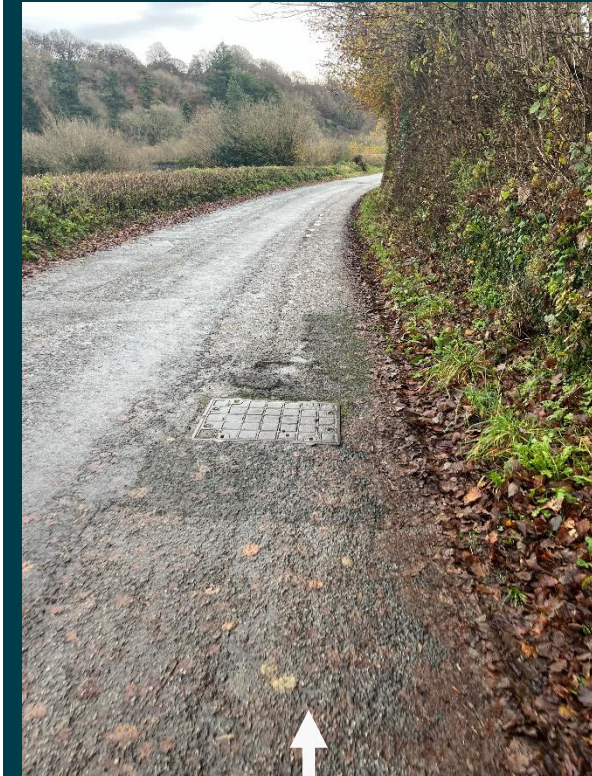
*“Have to walk beside the road in some areas leading onto Liskeard from Dobwalls, like the entrance leading to hillfort primary.”
(Walker)*

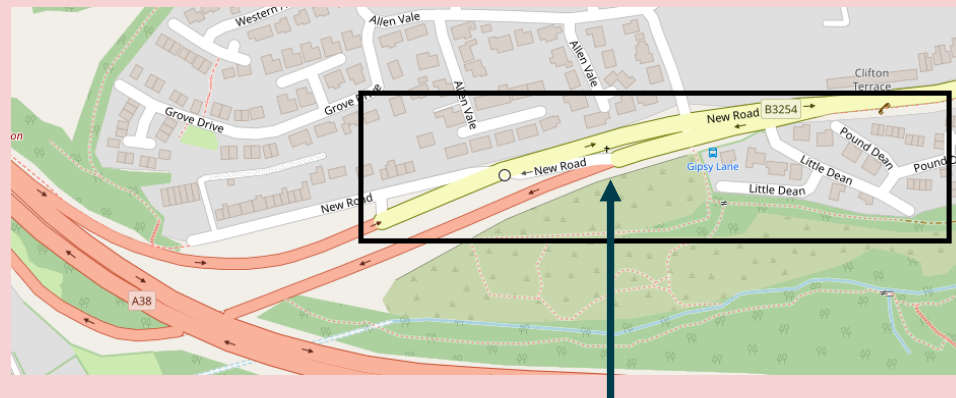
Part of New Road that joins into B3254

- Lack of segregation between walkers and wheelers on shared use paths.
- Poor road surface quality on New Road.
- Safety concern for wheelers coming off of the eastbound A38 slip road onto New Road, particularly at the junction with Gypsy Lane, due to speeding traffic and parked vehicles.
- Paths can be difficult to run on due to poor maintenance.
- Safety concerns for walkers with children using the paths, particularly due to issues with traffic and needing to share road space with other users (i.e. vehicles, wheelers etc.).
- Having to walk beside the road in some areas causes safety concerns, particularly paths from Dobwalls to Liskeard (see picture).
- Poor lighting throughout the site.

“I would like it if they were to put some of that quiet tarmac down here, so that I don’t hear the noise go past.” (Walker, Accompanied Journey)
