Riders, Walkers, Wheelers Strategic Road Network Research South West Region: A38 Devon Expressway

March 2024

A38 Devon Expressway (Lee Mill Industrial Estate – Ivybridge)

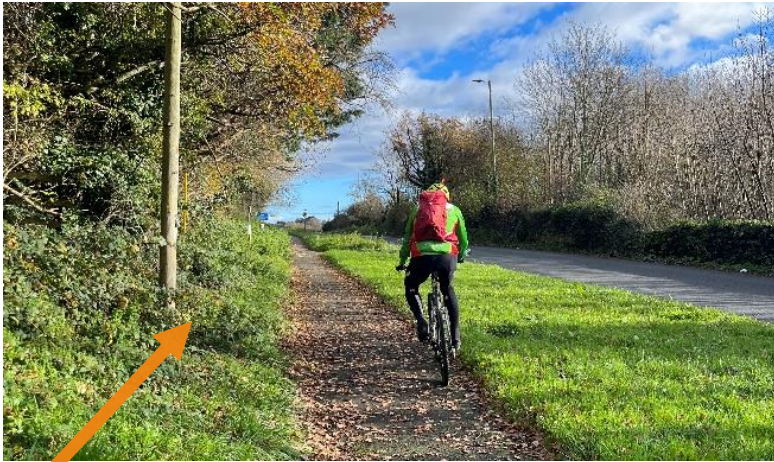
*“In the middle of the pitch black, I’m not gonna come down here cause they’re not gonna see me [...] I’ve never seen anyone later than sort of 5pm when I’ve been down here.”
(Walker, Accompanied Journey)*

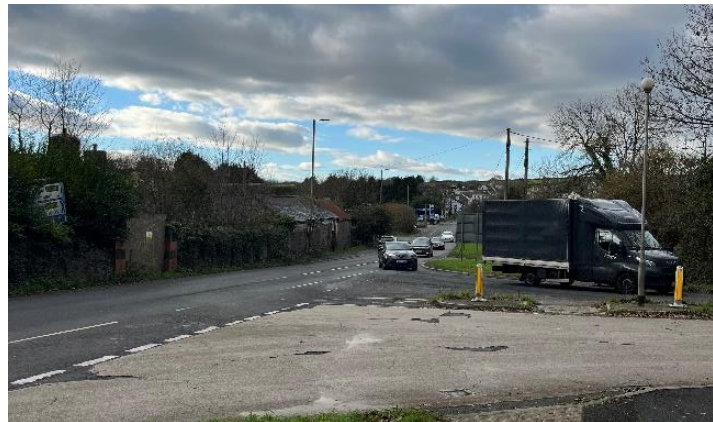
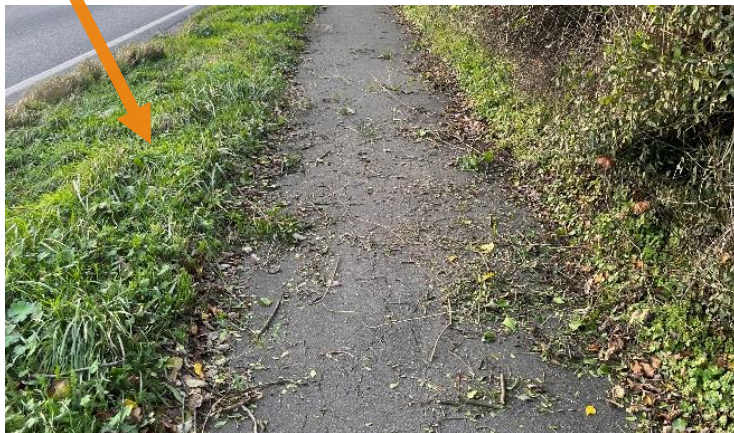
“If you slipped and fell, or hit a tree that’s hanging down, it’s quite narrow. [...] There’s not even a little wall here to stop you.” (Wheeler, Accompanied Journey)

*“This isn't a *cycle path*, but a shared path, and it's FAR too narrow.” (Wheeler, Interactive Map)*

- Lack of physical barrier between wheelers and traffic can make wheelers feel unsafe.
- Narrow path leads to user conflict (see picture) – with other wheelers and walkers, particularly for those using a recumbent, due to the additional width.
- Overgrown vegetation causes hazards to wheelers, particularly overhanging trees.
- Lack of a smooth surface makes cycling more challenging.
- Car headlights obscure vision when travelling in the dark.
- Noise pollution due to proximity to the A38.
- The junction of Beech Road and New Park Road feels dangerous due parked cars causing poor visibility and fast traffic.
- Lack of segregation from traffic at the beginning of Link 1 (on Beech Road).
- Path often has litter.

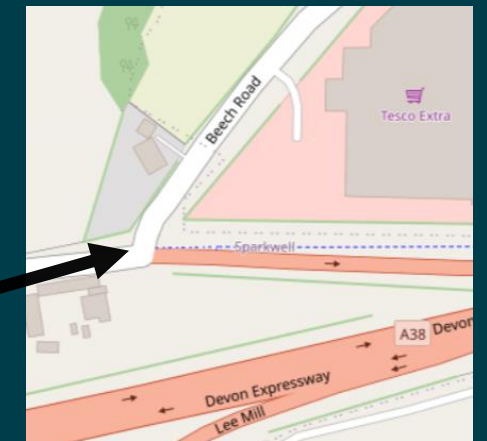
“When I first moved down here, I didn’t really realise how you could walk along here [...] Maybe signs, basic pedestrian signs, because I’ve not seen any signs that this is a cycle route [...], there’s nothing about pedestrians or anything like that.” (Walker, Accompanied journey)

- Provide a physical barrier between the shared use path and the A38 to improve feelings of safety.
- Widen the shared used path to improve access for wheelchairs, recumbent bikes, and prams, as well as for two wheelers to be able to pass each other.
- Provide regular maintenance of overgrown/overhanging vegetation to improve safety of using the path.
- Re-surface path to improve surface quality.
- Provide painted cycle lanes or off-road path for wheelers on Beech Road.
- Install traffic calming measures on Beech Road and Cadleigh Lane, particularly at the junction of Beech Road and the A38 Devon Expressway.
- Provide regular maintenance of the off-road path that links in to Tesco car park.

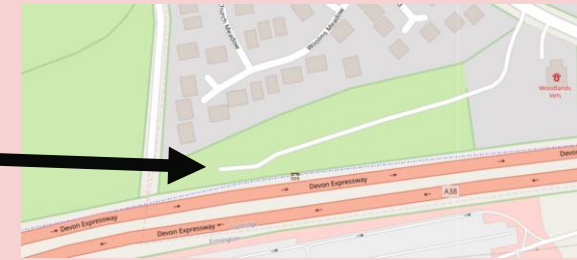
"It [referring to the path] should be a bit wider [...] It's not made for wheelchairs, prams, if somebody is walking with a pram. it's quite difficult, if you got a pram and I'm cycling here, I'm almost touching you [...] Even two cyclists, it doesn't leave a lot of space for error." (Wheeler, Accompanied journey)

- Provide a physical barrier between the shared use path and the A38 to reduce the risk of users slipping/falling into traffic, and improve feelings of safety.
- Widen shared use path (see picture) to improve access for wheelchairs, recumbent bikes, and prams, as well as to enable two wheelers to pass each other.
- Provide regular maintenance of overgrown/overhanging vegetation to improve safety of using the path.
- Re-surface path to improve surface quality.
- Improve lighting.
- Create a new link from the cycle path into Ivybridge through Sunnydale Close.
- Create a segregated cycle lane on Cornwood Road.
- Remove 'cyclists dismount' signs at the roundabout in Ivybridge and create a raised crossing over Woodland Road, with signed cyclist priority, to avoid use of the roundabout.
